# ASSESSMENT REPORT OF PASAKHA INDUSTRIAL ESTATE, PHUNTSHOLING, BHUTAN

FEBRUARY 2019

**Prepared by:**  
Centre for Science and Environment

**For:**  
The National Environment Commission  
Royal Government of Bhutan

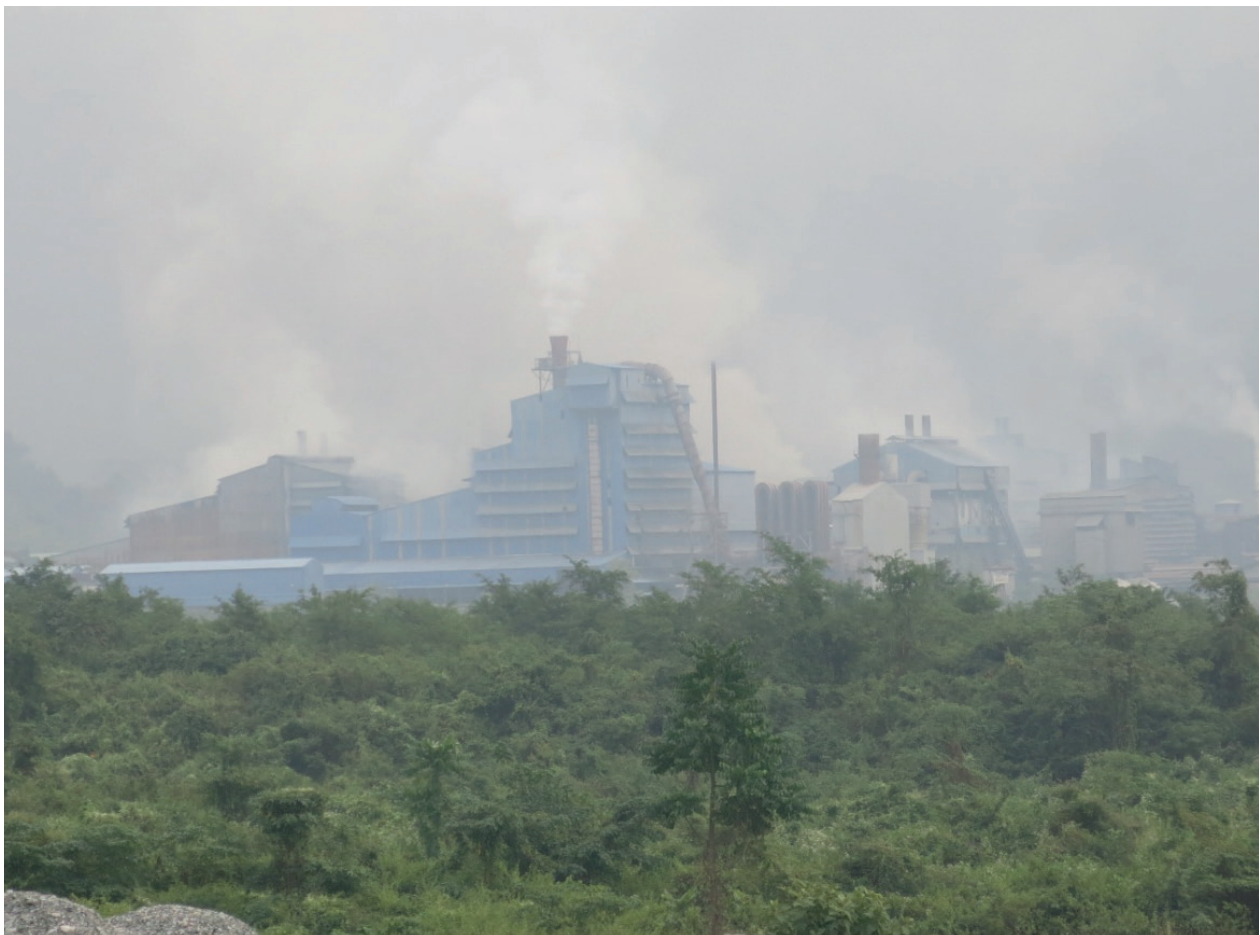
Pasakha industrial area is located in a valley (surrounded by mountain from three sides), this natural restriction leads to poor dilution and dispersion of the pollutants, and therefore, they remain confined in the valley for a long time.

*Figure 3: Poor dispersion of pollutants in Pasakha Industrial Estate*

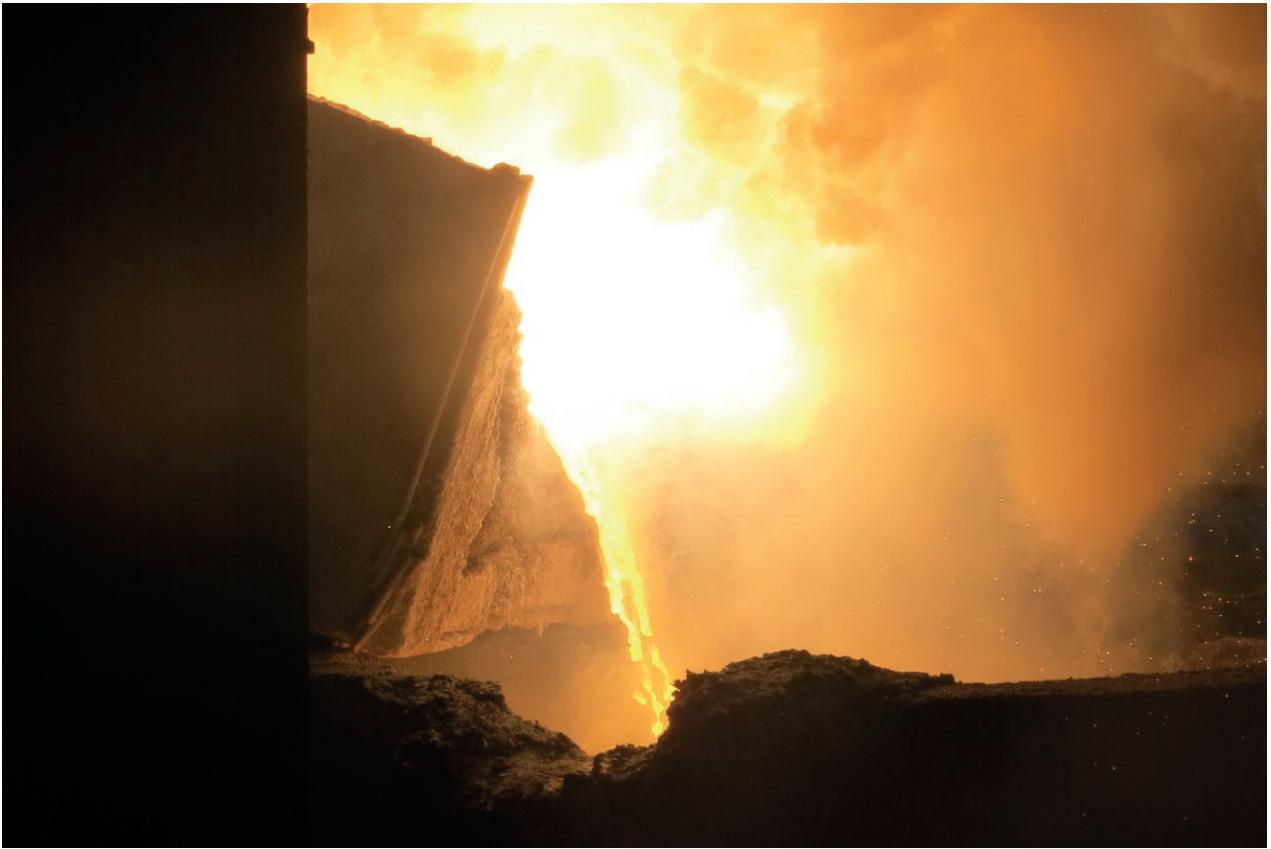
*Figure 7: Emission during tapping process in ferro-silicon industries*

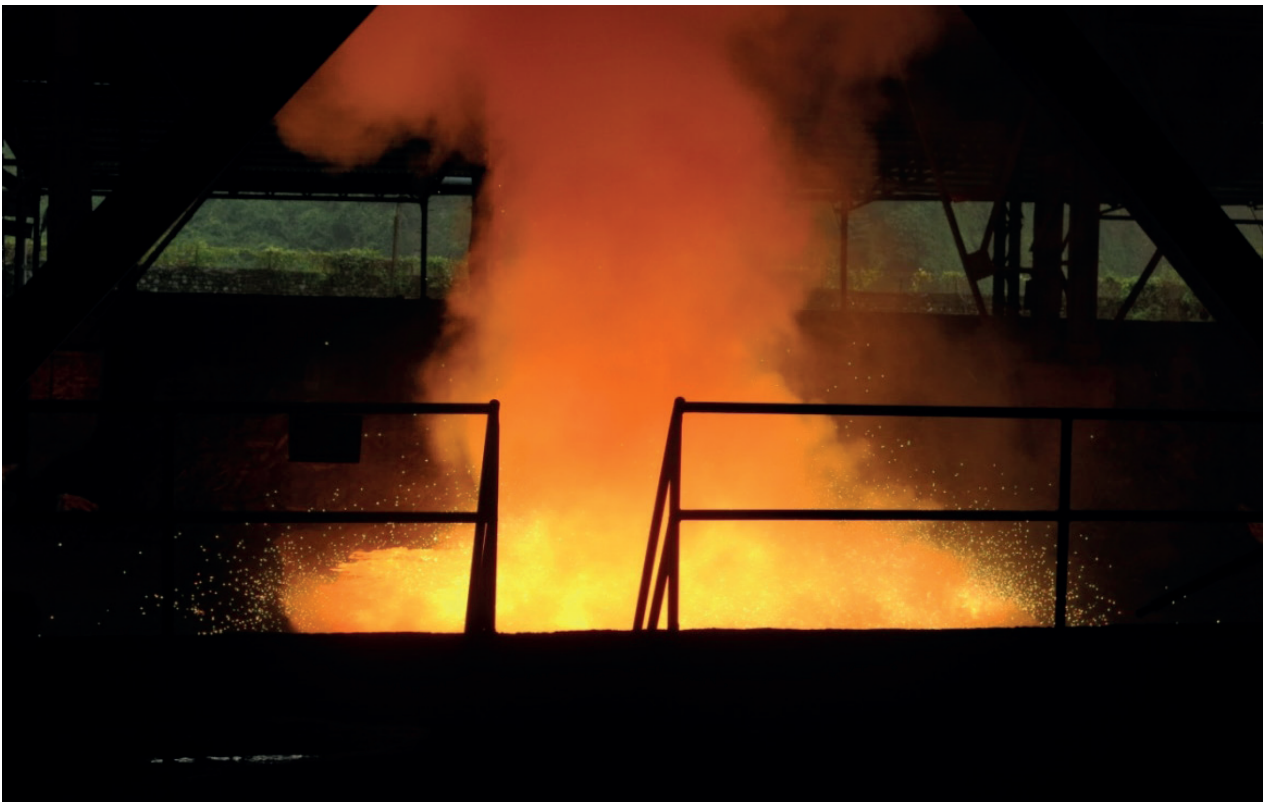
*Figure 8: Gaseous emission during tapping process*

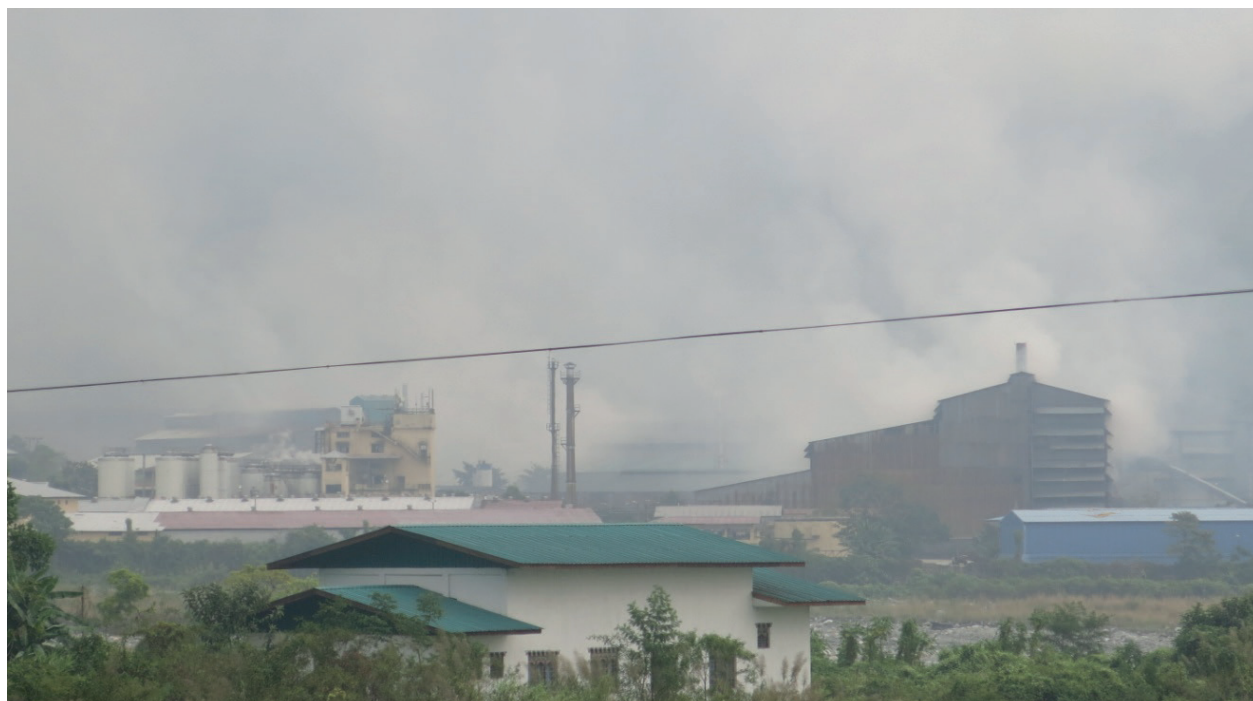
Figure 9: Cumulative impact during 3–4 tapping which occurs simultaneously

6. High emission were observed during tapping process, at a time 3 – 4 tapping occurs in the estate and this adds to the emission of the pollutants in the area;

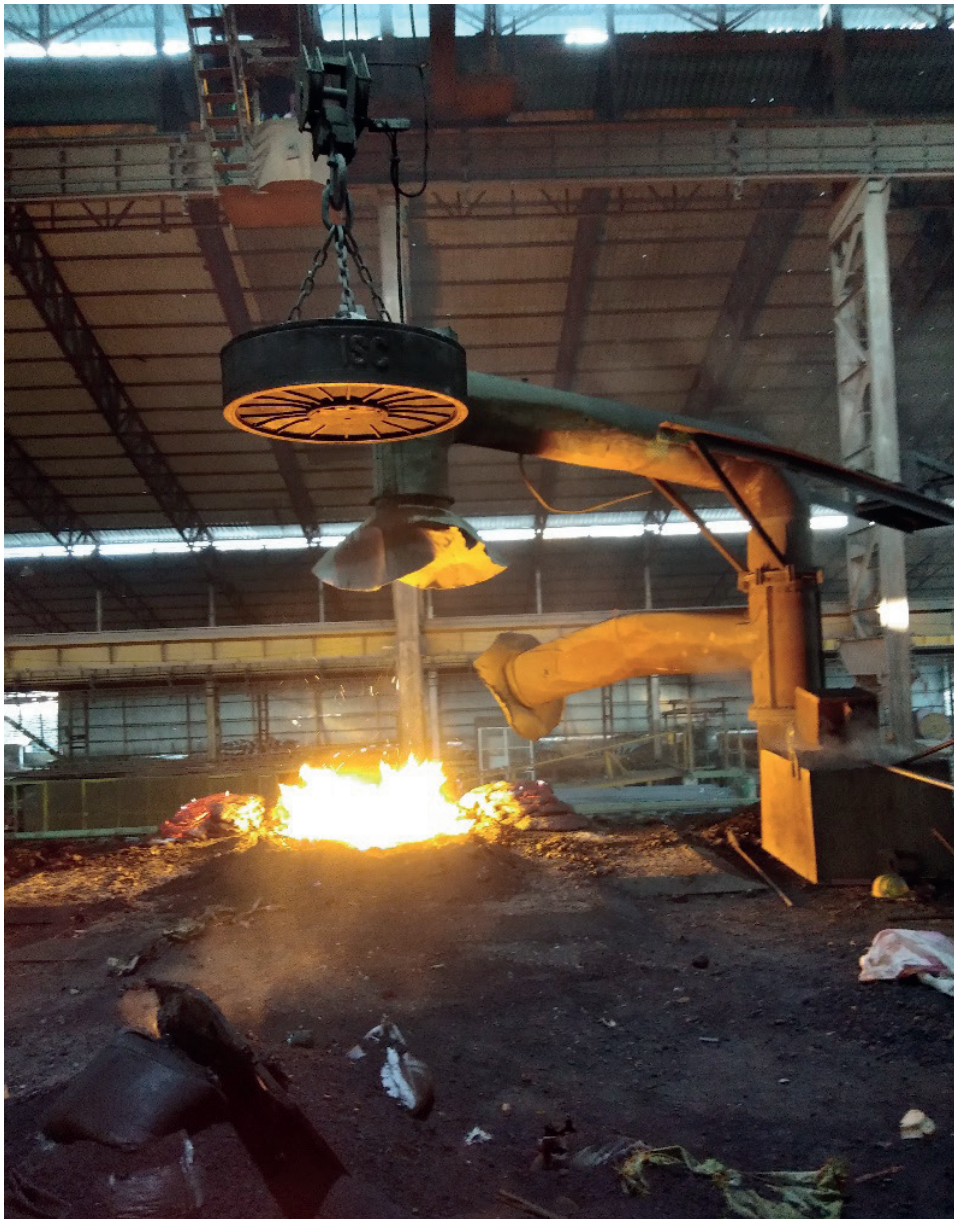
The steel industry, which was visited was Lhaki Steel and Rolling Mills. The unit has installed the Air pollution control system, namely, 'Low canopy movable hood fume extraction cum bagfilter type control system'. But still substantial fugitive emissions from the furnace were visible. The main reasons why these emissions cannot be controlled in this case are explained below:

*Figure 10: Inadequate Fume extraction system at Lhaki Steel and Rolling Mills*

Even if penalty or fine is levied on the unit, the fact remains that the APCD cannot be properly operated without a major overhaul and operationalizing of bag-filter system followed by its adequacy testing. **The present APCD system is grossly inadequate and cannot work, without major overhaul. Accordingly, the directions should be issued.**

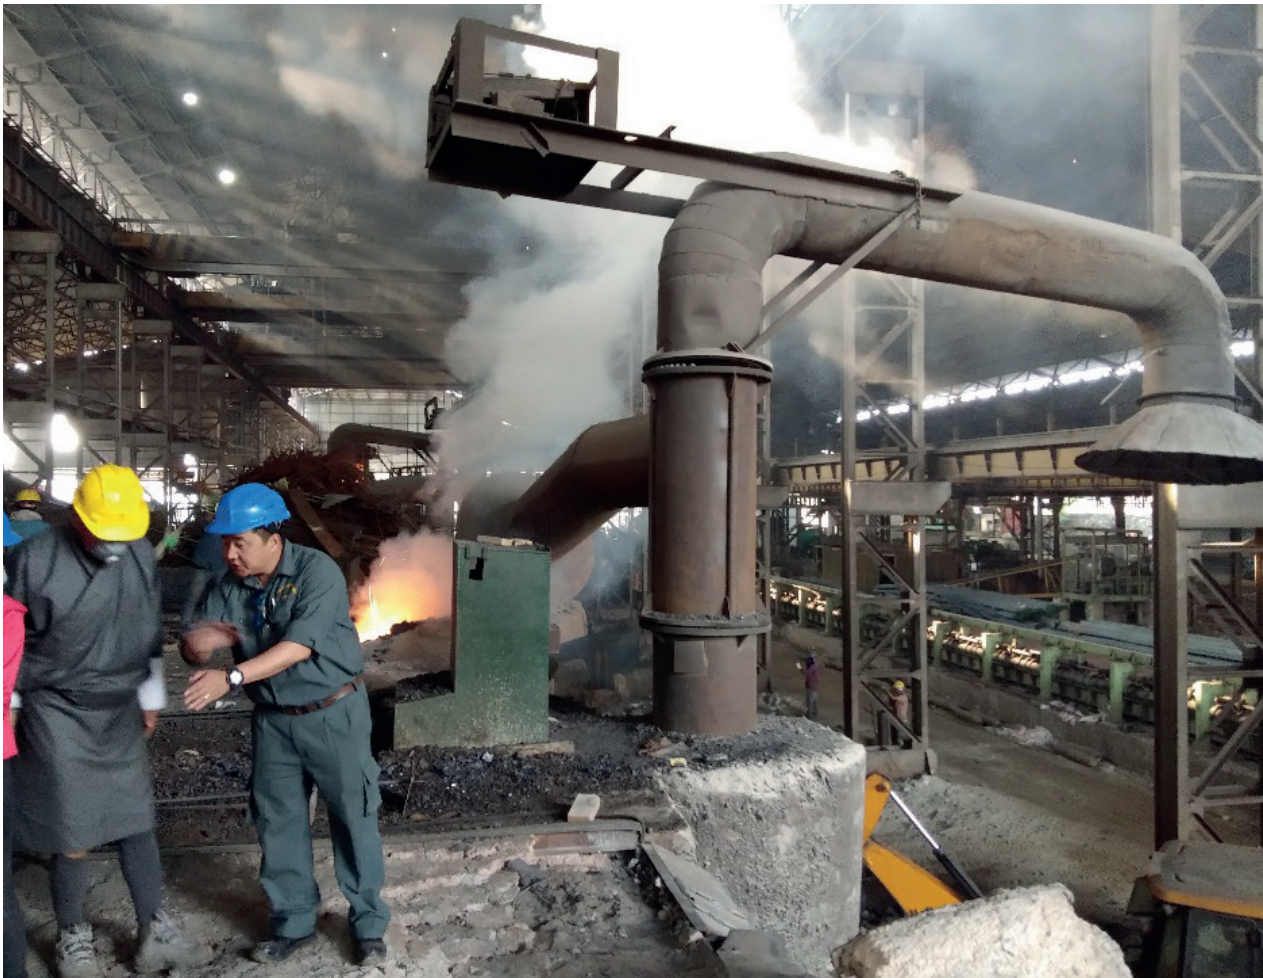
A small hole of 10 mm diameter was made in the duct near the hood and static pressure was measured using a U tube Manometer, and it was found that there is 0 (zero) mmWC. Static pressure or suction power, which means, there is no suction at all. So, naturally, no gases/fumes are getting extracted into the hood. It could be said that the gas extraction efficiency of this system is 0 per cent. For technical reasons, it can be said that the furnace is operating without any fume extraction system.

The hood at a height above head level, i.e. approx. at 2 to 2.5 meter high from furnace platform, is improper and ineffective. Also, the hood was damaged and deformed, its bearing alignment was also damaged, which made the hood movement harder. The hood can only be moved by crane magnet and cannot be pulled manually. Therefore the present position, height, shape, and hood movement arrangement is improper and hence will not extract any emissions from the furnace.

Figure 11: Ineffective fume extraction at Lhaki Steel

The hood should be as close to the furnace as possible, typically less than 1 meter from the furnace platform. Higher the hood, less effective will be extraction of fumes and also the volume to be sucked will be higher and hence the fan motor power will be higher and as a result the operating power cost goes up. It is very much possible to have the hood at about 0.7 to 1.0 meter above the furnace and several such designs are in operation in various induction furnaces in India.

For the effective extraction of fumes, the pulling and pushing movement of the hood should be smooth, such that only one workman should be able to push/pull easily, without much effort. It is wrong to use crane magnet to push/pull the hood, it can never work, only the hood will get damaged/deformed and its bearing alignment will be damaged, making the hood movement harder and harder, (which is the present case at Lhaki Steel). The smooth movement of the hood is a must for the success of this APCD, it needs to be designed accordingly. The hood should only be pushed and pulled manually or by using an electrically operated gear-pinion arrangement, but never by magnet crane.

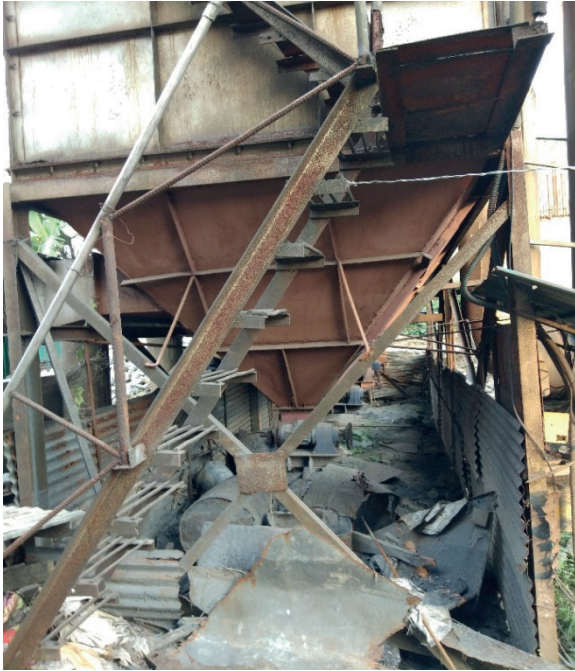
Figure 12: Junk lying below the Bag-filter hoppers at Lhaki Steel

At the inlet duct of the bag-filter, the static pressure was found to be 0 (zero) mmWC, which means, there is no gas flow to the bag-filter, this may be because the bag-filter is completely choked. Also the pulse jet cleaning arrangement is not working at all.

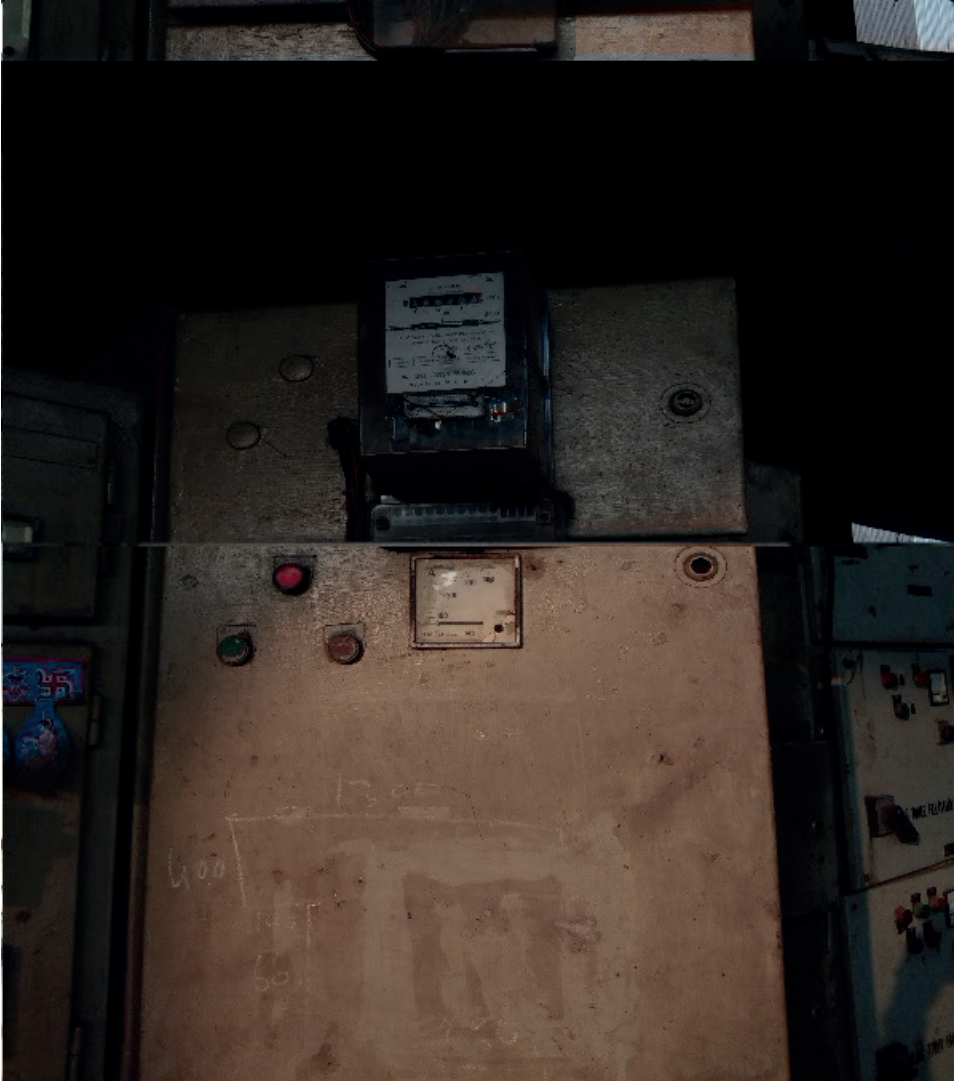
The unit has installed a separate energy meter on the fan motor, as in Figure 13. In this case, even if the fan is running and the energy meter is showing consumption of electricity in KWh, since the bag-filter is choked there cannot be any extraction of emissions from the furnace and hence the very purpose of its installation is defeated.

Also, this is an analog meter and the data cannot be transmitted through internet and hence hourly or daily energy consumption is not recorded, nor it can be captured in software. All industries therefore should be directed to install only smart meters such that the data can be captured by computer and analysed through software.

*Figure 13: Analog energy meter at the fan motor of Lhaki Steel*

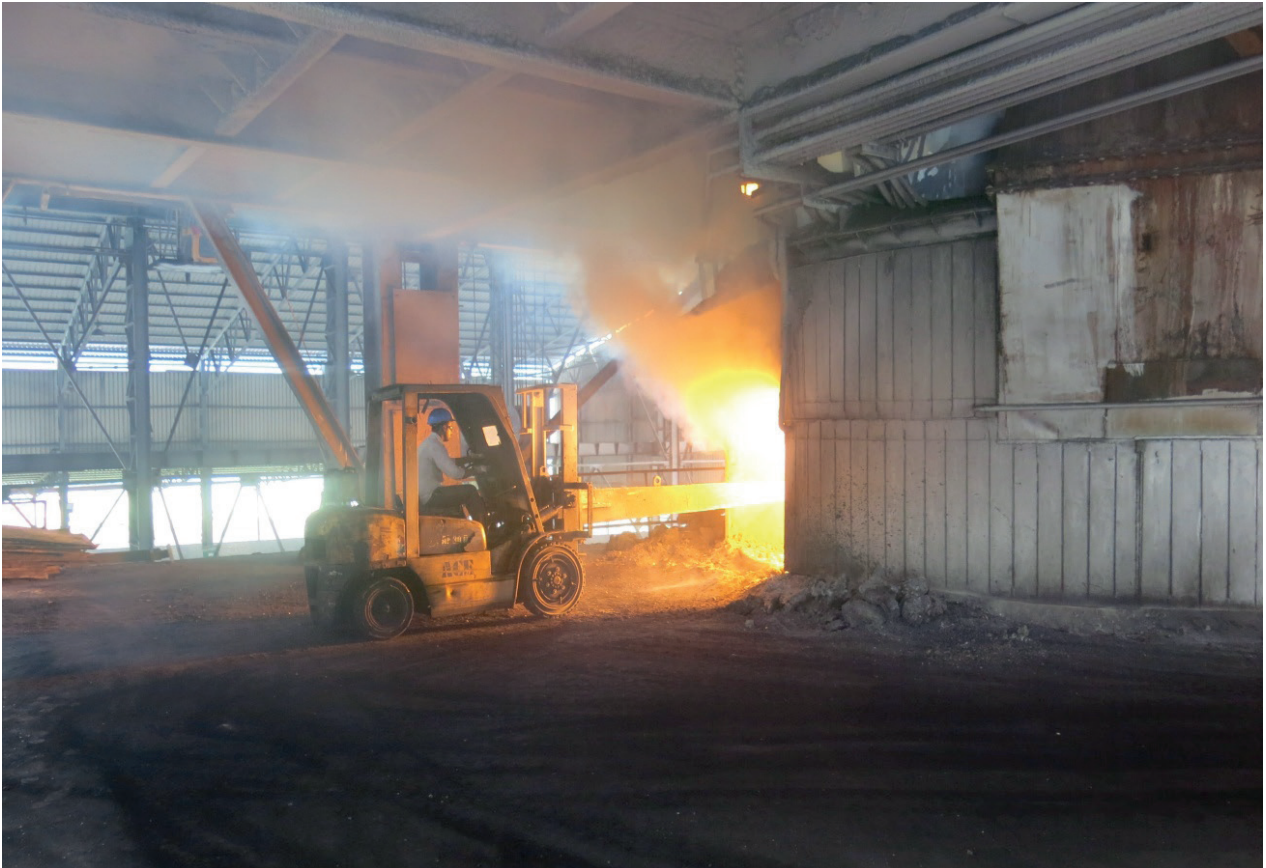
*Figure 14: Fugitive emissions from open furnace—Ferro Alloy industry*

To assess the problems, a diagnostic study is required by an expert to do various measurements on the installed systems, like static pressure, temperature, gas volumes extracted etc. After this study, appropriate modifications could be suggested and the industries could implement them.

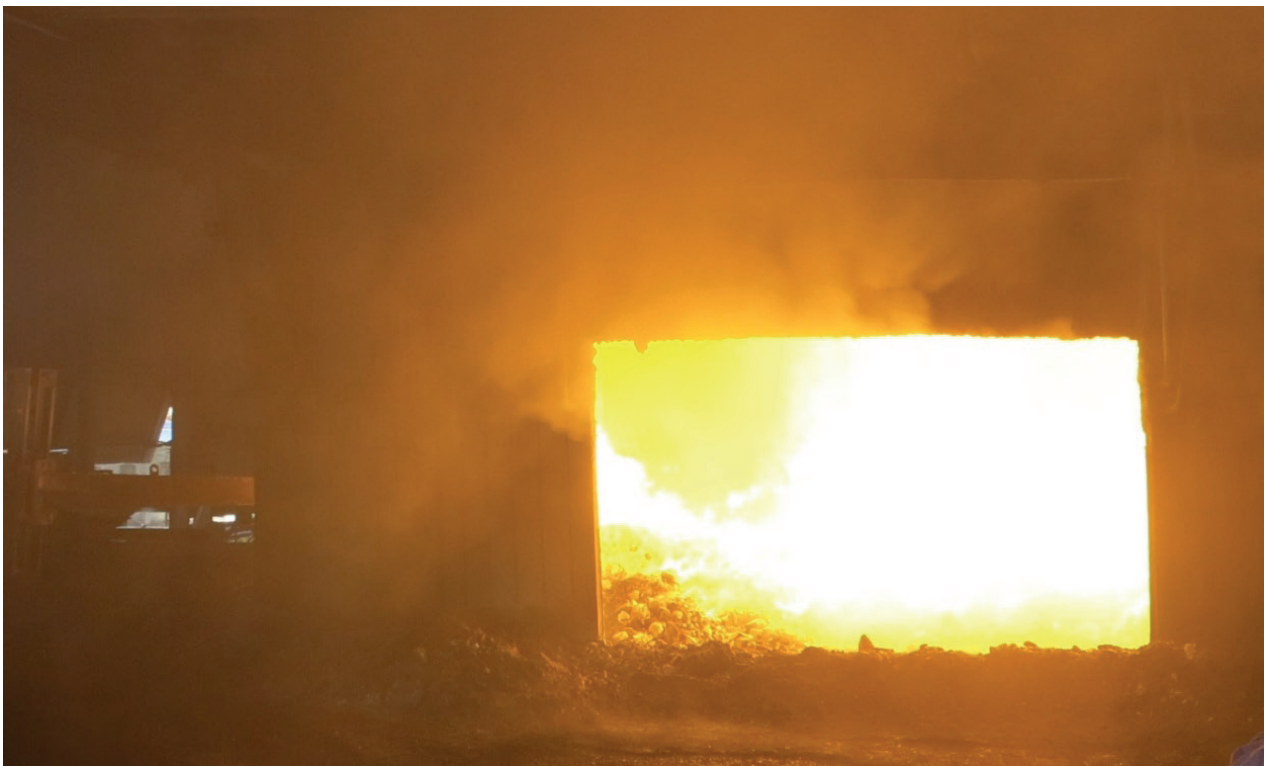
*Figure 15: Fugitive emission from open furnace due to inappropriate functioning of fume extraction system*

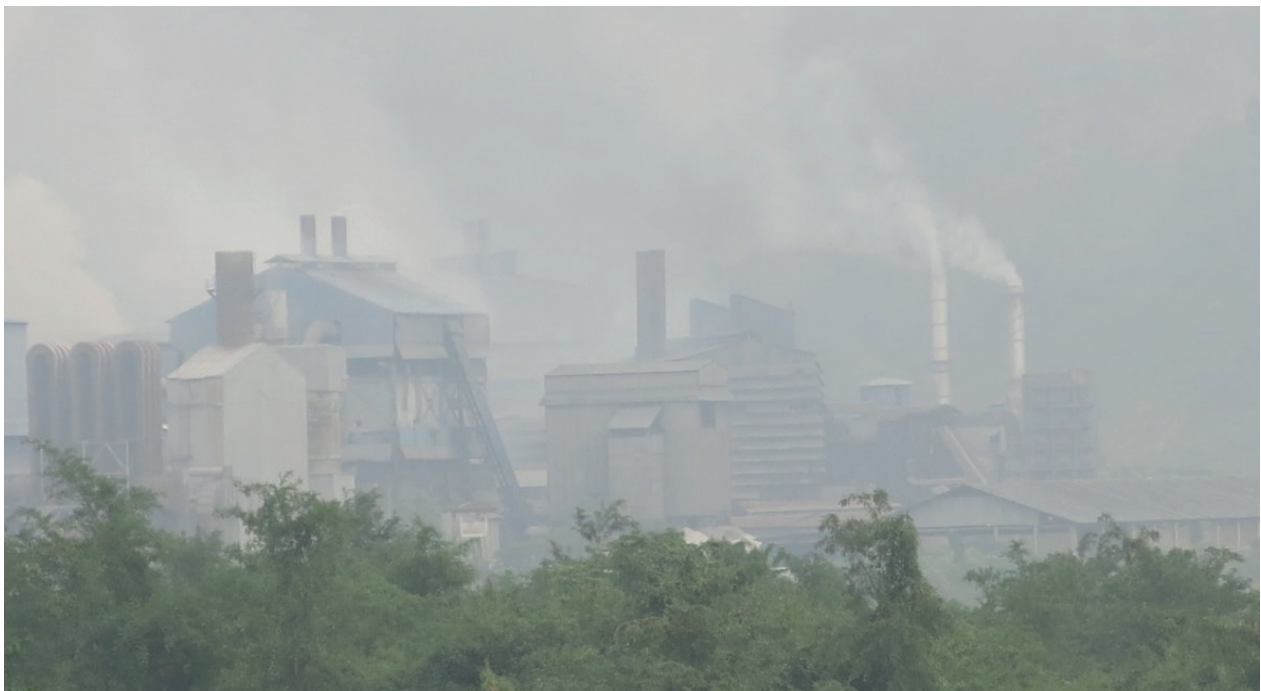
Ambient air quality of Pashaka industrial area is deteriorating due to the cumulative impact of industrial emissions. In the industrial zone there are many other industries which contribute to the pollution load of the area.

*Figure 18: Cumulative impact industrial emission on air quality of Pasakha*

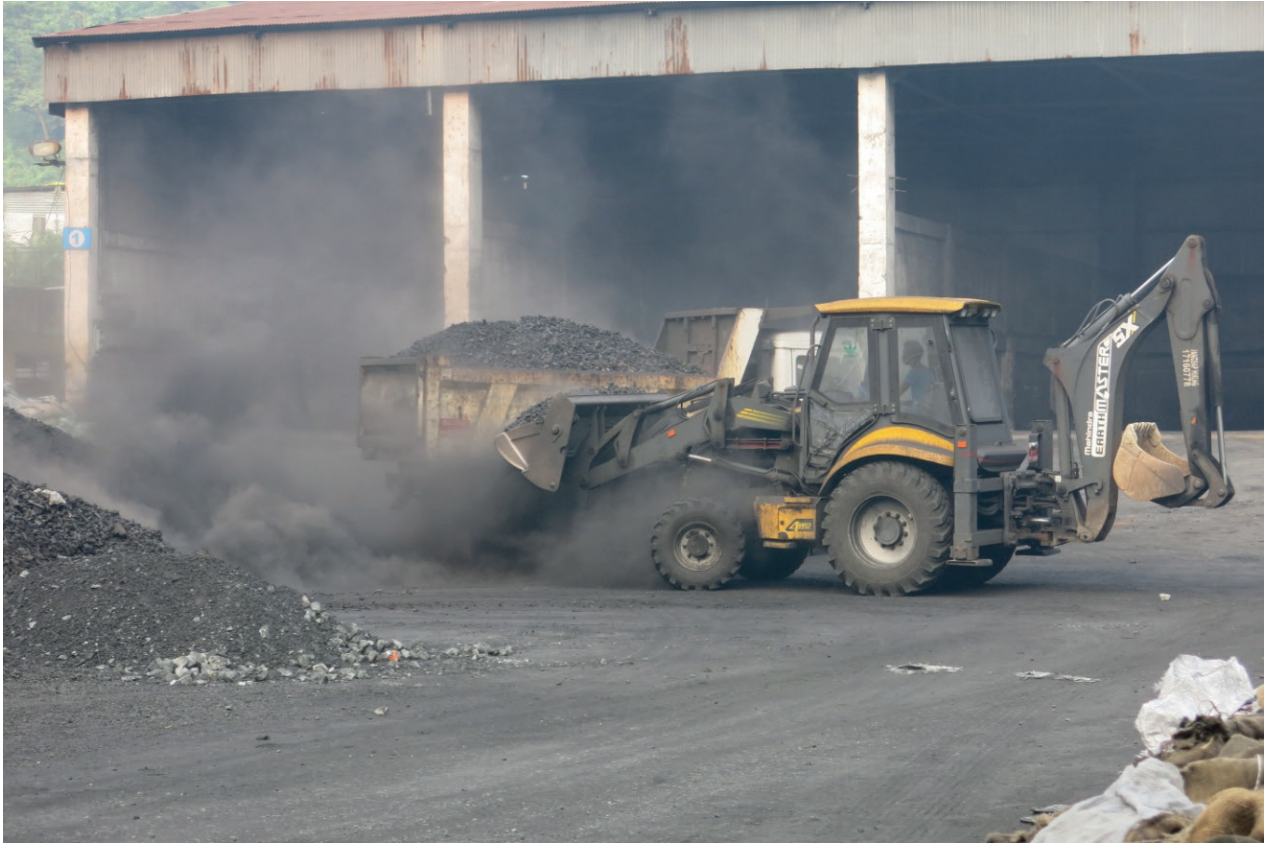
The road condition of the industrial zone is very poor and the truck movement is also a contributing factor to the pollution load. In most of the industries the material handling and storage is not adequate and most of the raw materials are stored in open area whereas it should have been in the covered area.

*Figure 19: Fugitive emission during loading and unloading of material—most industries store raw materials in open*

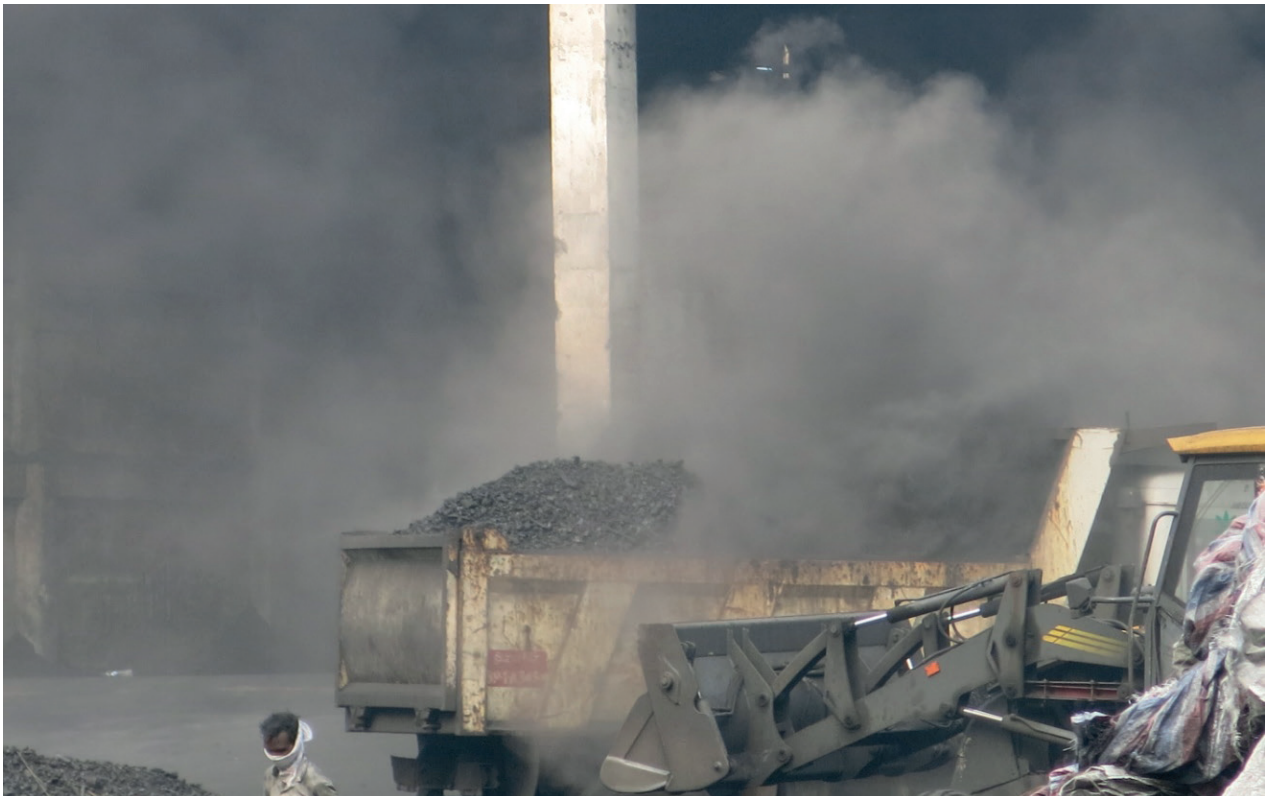
*Figure 21: Poor road condition in the area adds to the fugitive emission during transportation of raw material*

10. Conduct a pilot study in one plant for improving efficiency of GCP, so that NEC can take strategy level decision.
11. Road condition of the estate needs to be improved so that the fugitive emission from it can be reduced.

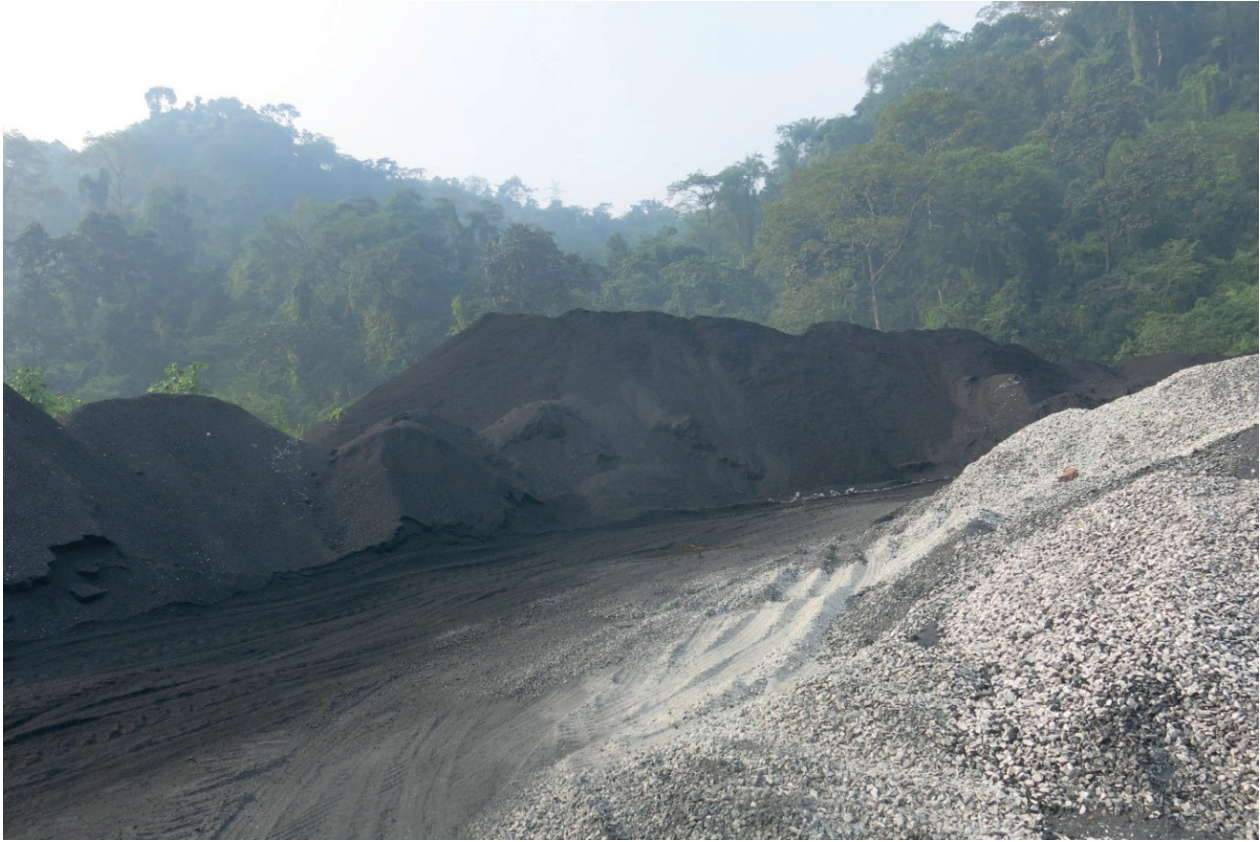
*Figure 20: Fugitive emission during loading and unloading of material*

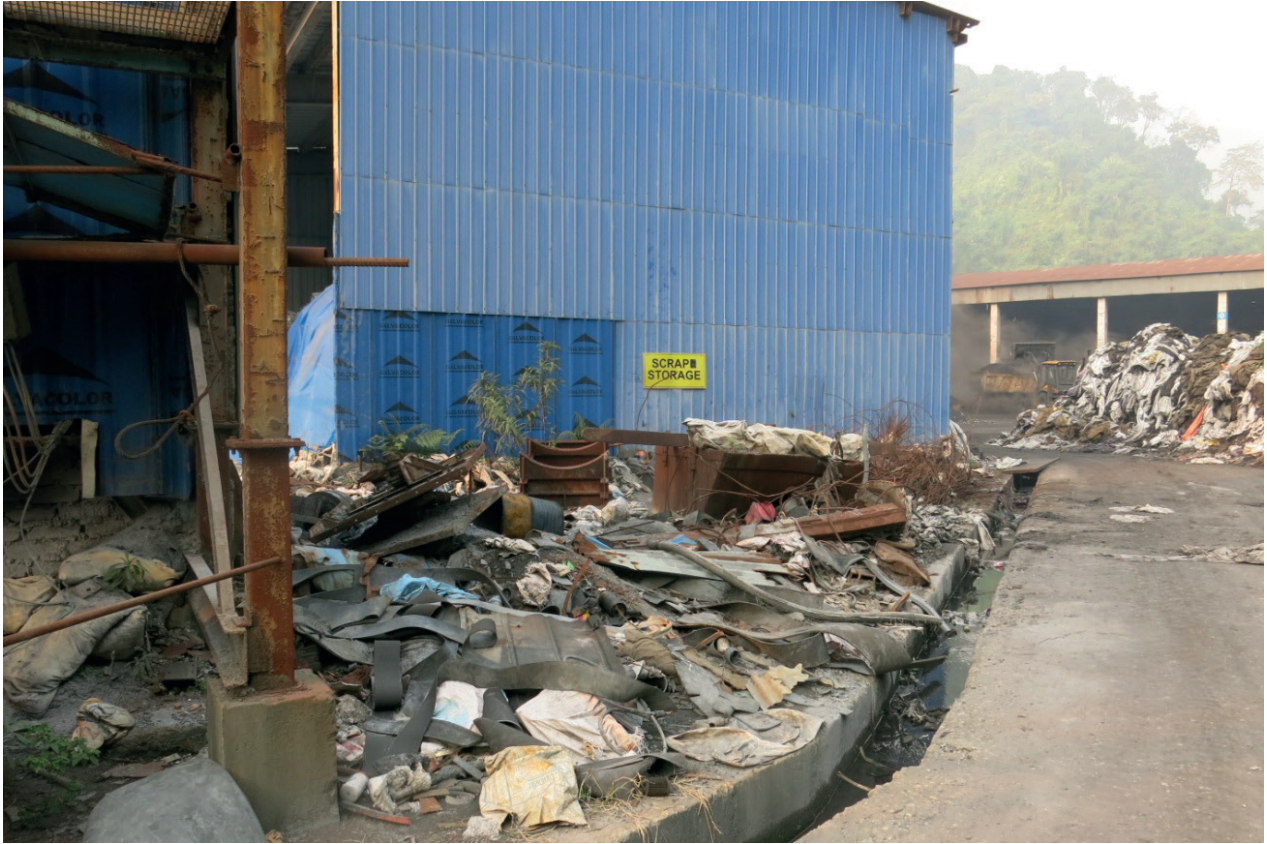
1. Housekeeping within the industry was very poor in all the six industries visited;
2. Access to stack was not safe in few industries;
3. Waste handling system was found to be poor, in most of the industries the ruined bag-filters were found thrown here and there, without any designated place for storage;

Figure 22: Poor housekeeping in most of the industry

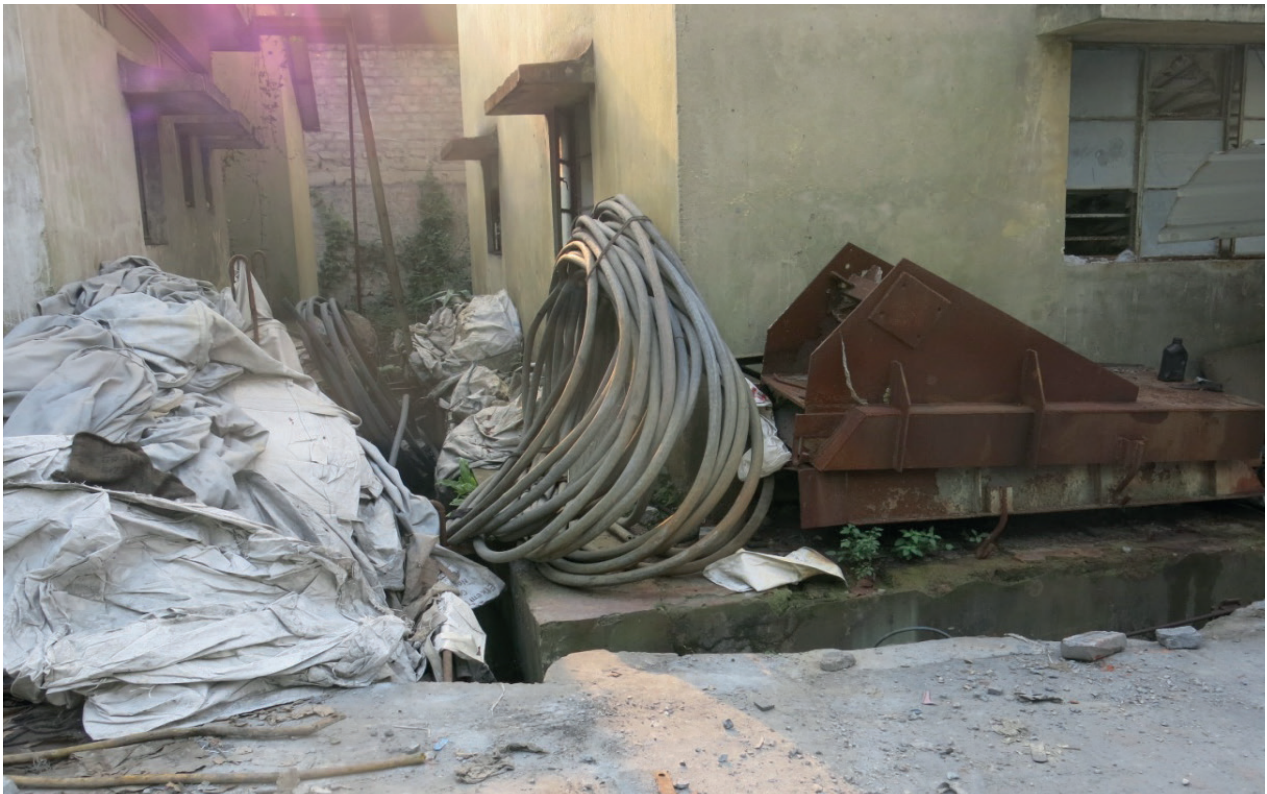
Figure 23: Poor housekeeping – storage of waste without any designated place

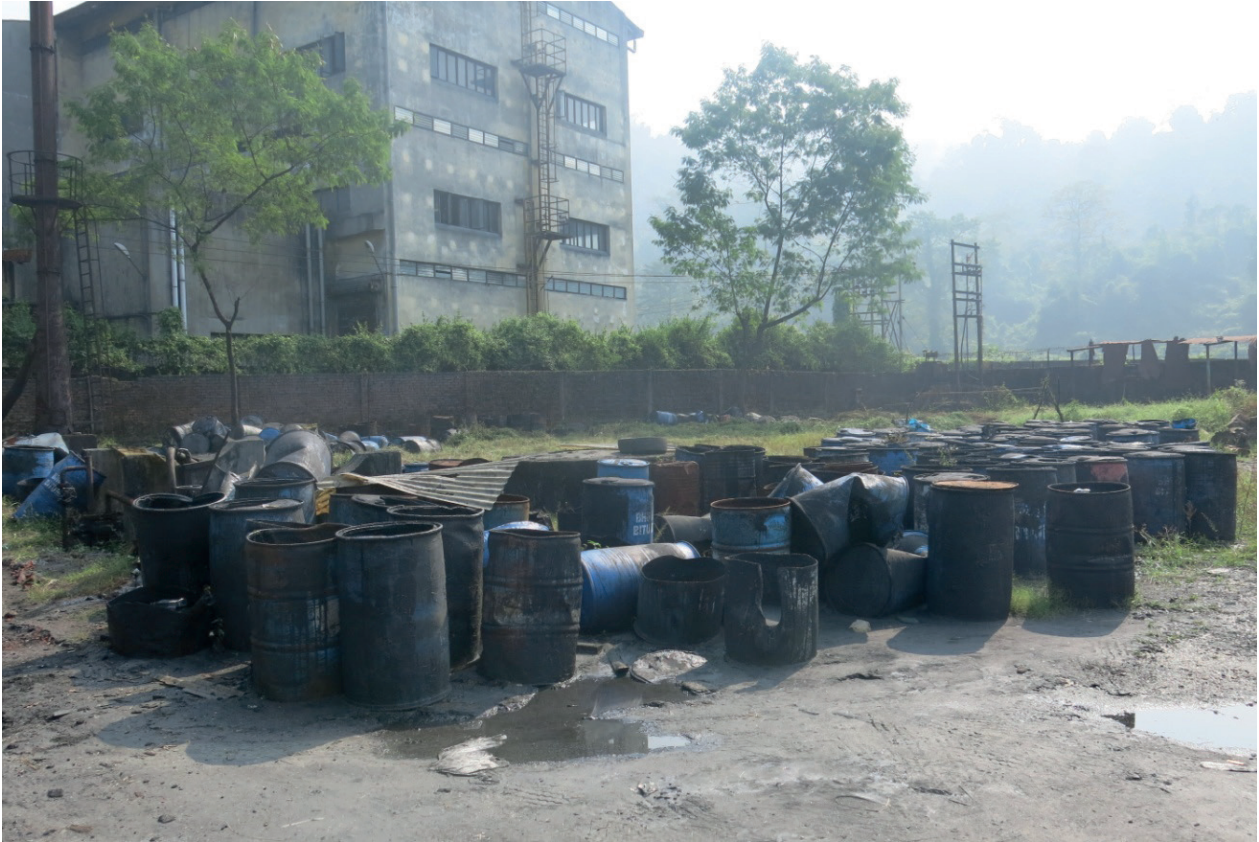
*Figure 24: Bhutan Bitumen poor housekeeping —no designated place for storage*

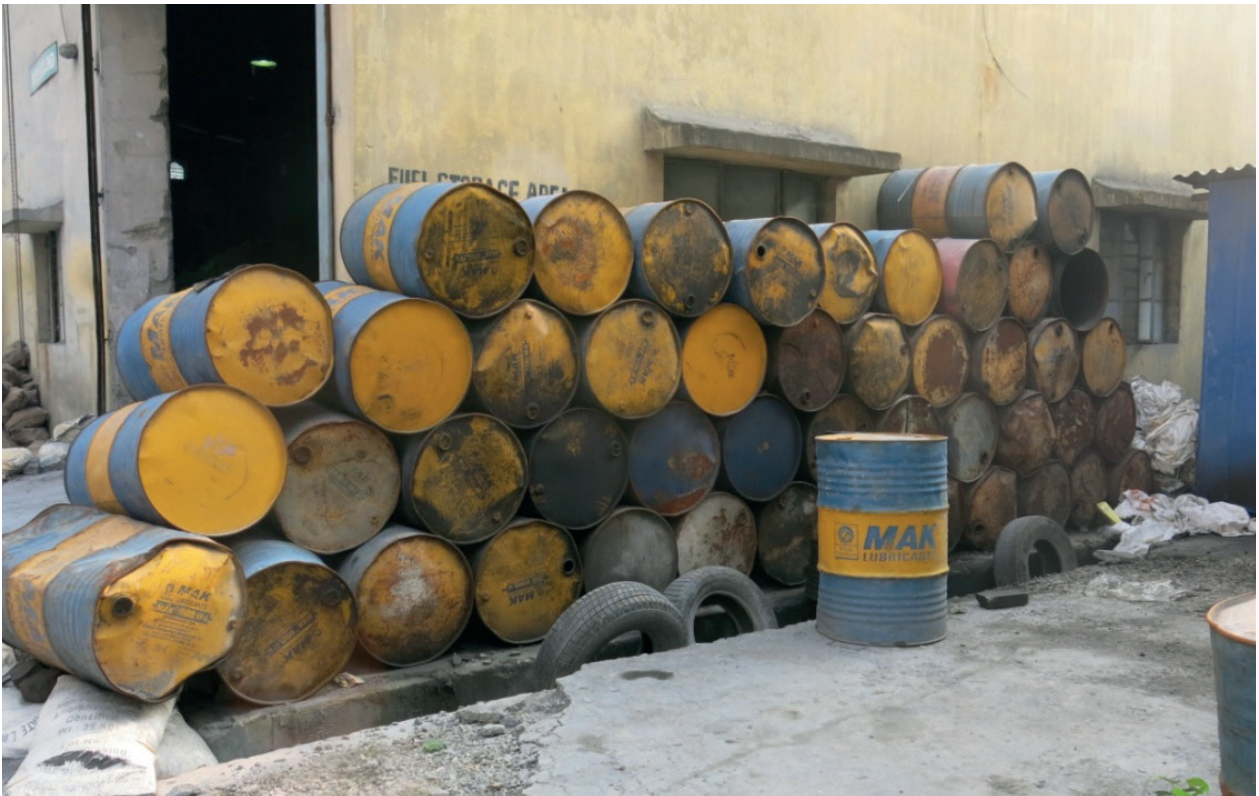
*Figure 25: Storage of used oil drums near storm water drains — can lead to water contamination*

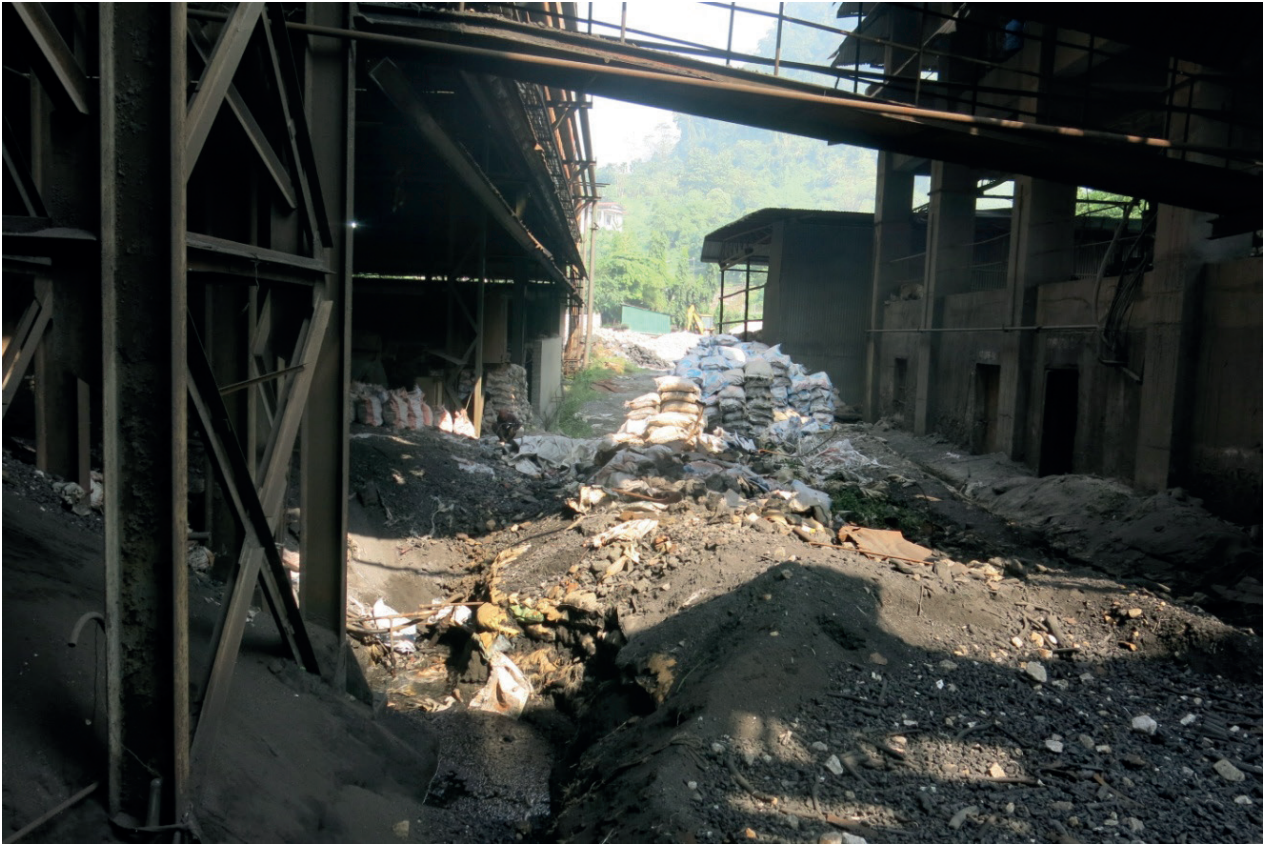
*Figure 26: Access to stack and gas cleaning plant blocked*

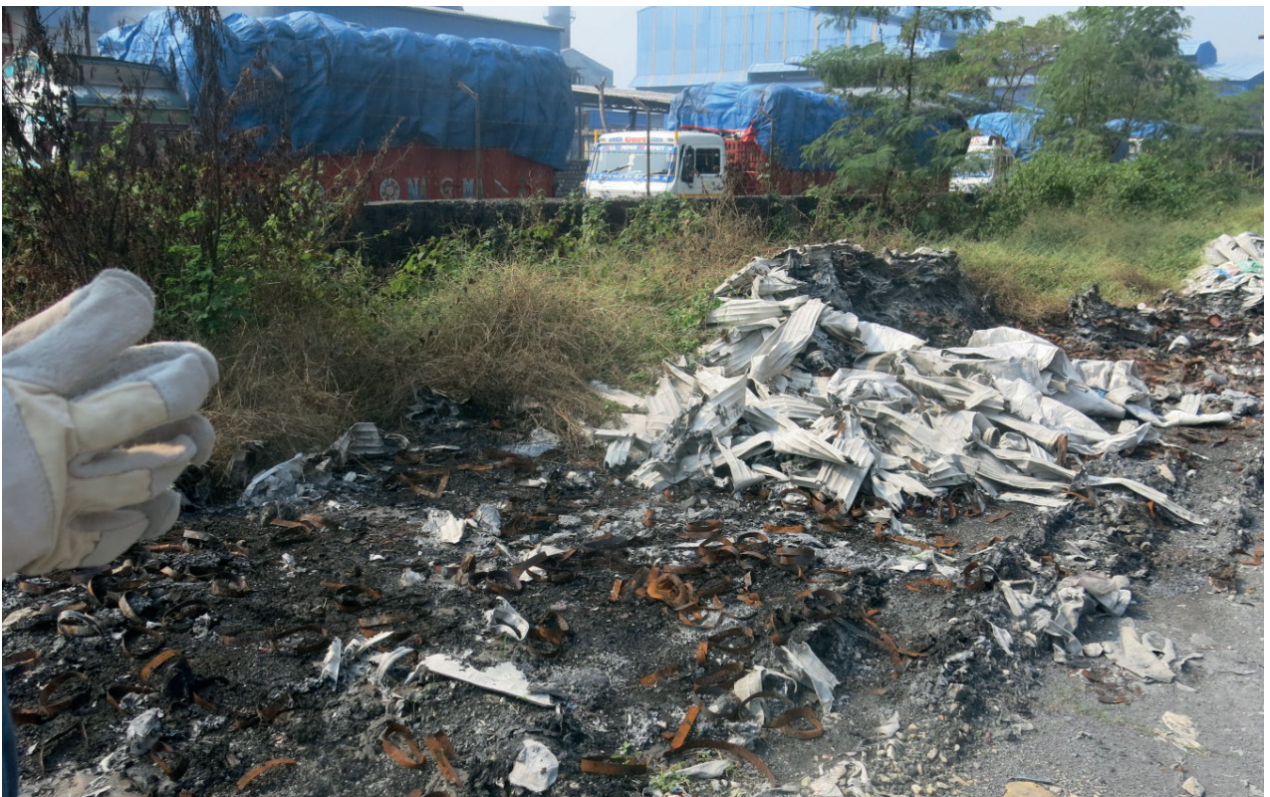
*Figure 27: Burning of rejected bag filters and other waste in the open*
