# ASSESSMENT REPORT OF PASAKHA INDUSTRIAL ESTATE, PHUNTSHOLING, BHUTAN

FEBRUARY 2019

**Prepared by:**  
Centre for Science and Environment

**For:**  
The National Environment Commission  
Royal Government of Bhutan

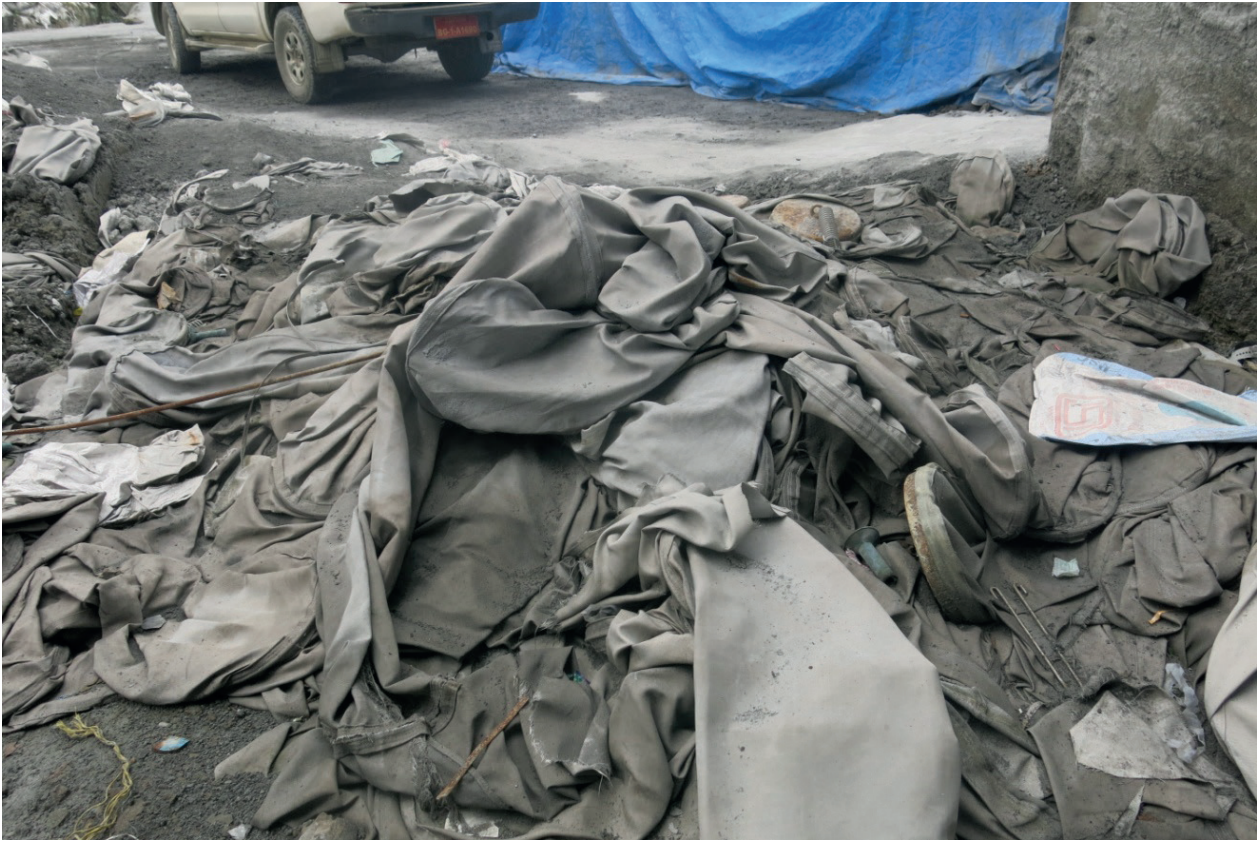
**Figure 28:** Discarded bag filters—no designated place for disposal

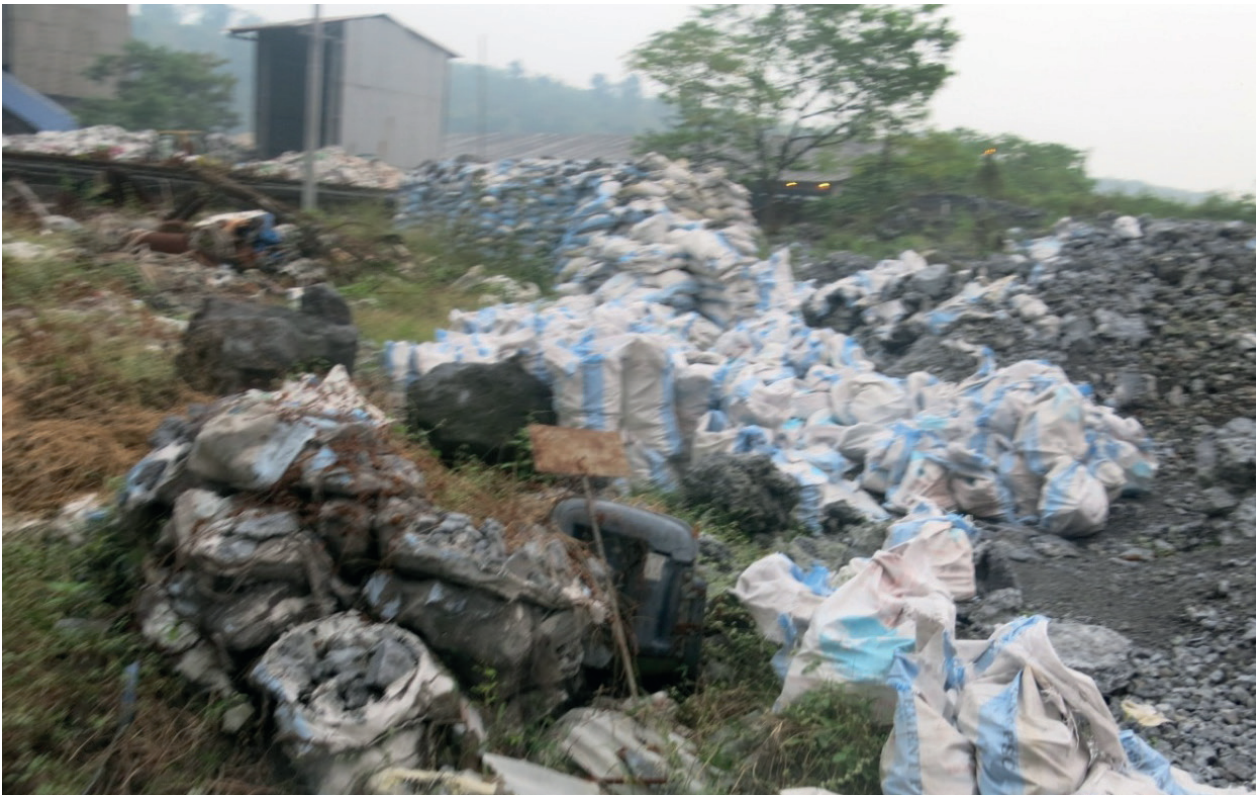
**Figure 29:** Raw material storage and handling not proper, it adds to the fugitive emission

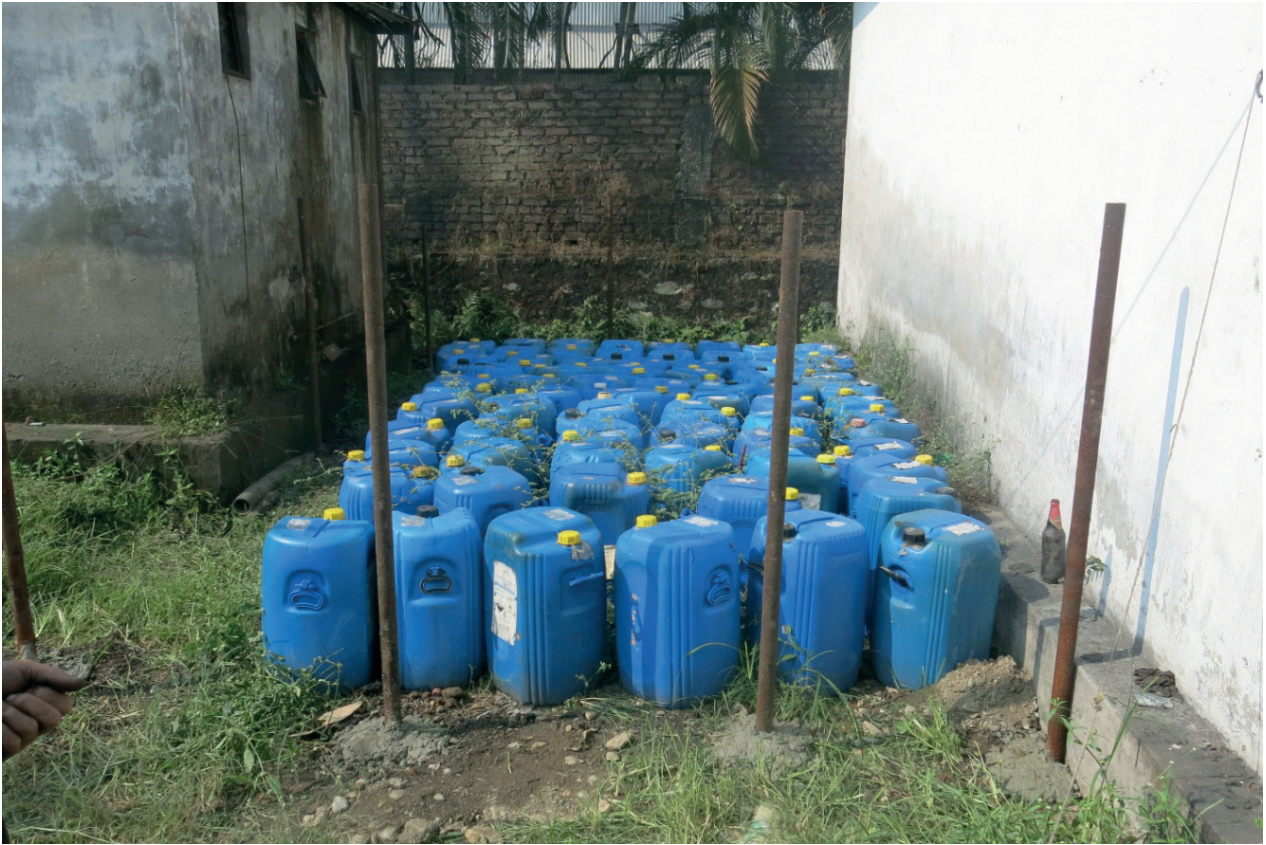
*Figure 30: HCL stored in the open without any liner—high risk of soil and ground water contamination*

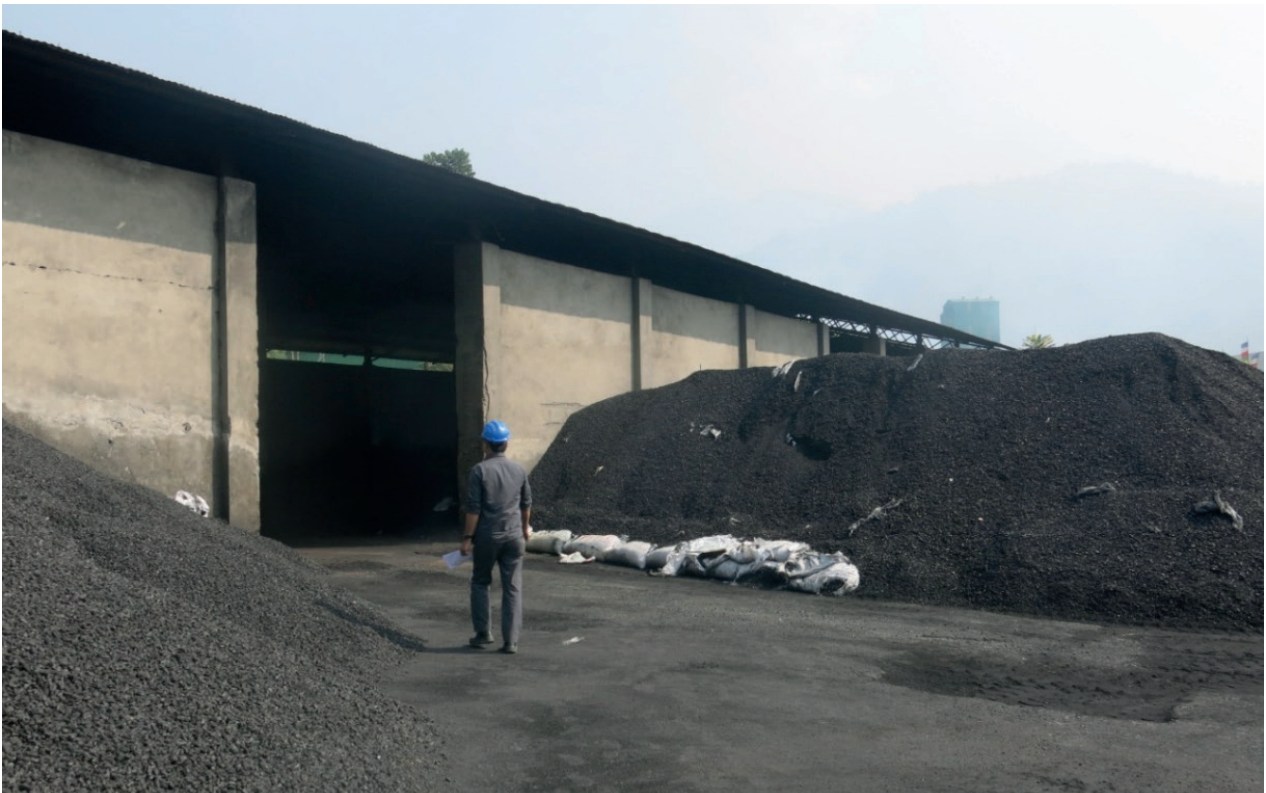
*Figure 31: Raw material storage in open even though facility for storage is available*

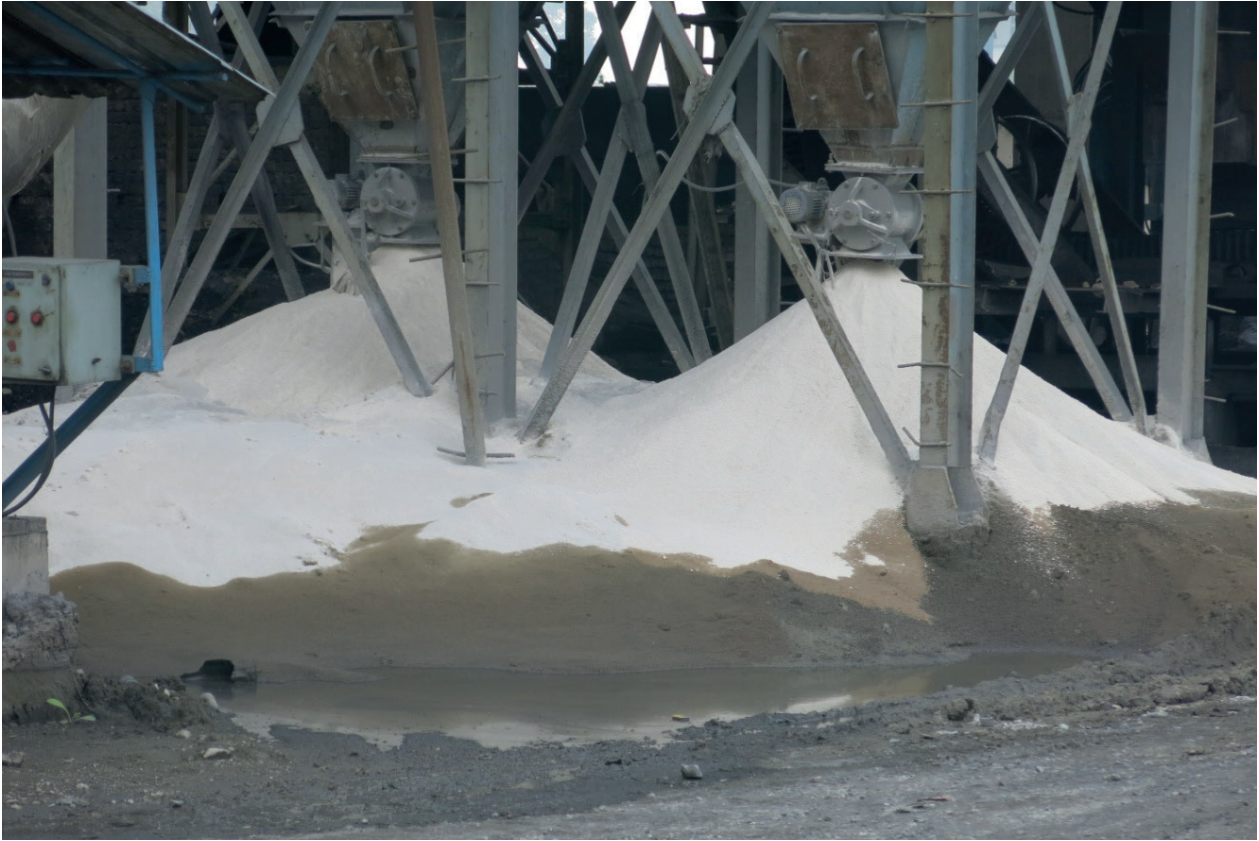
7. Dust collection mechanism from the bottom of the bag-filter hoppers are very poor, further it is done manually at most of the places which is hazardous for the workers working in the area;

*Figure 32: Poor dust handling mechanism from hoppers of gas cleaning plants*

14. Mechanized collection of FeSi dust from the bottom of the bag house, currently in most of the industries it is done manually (see Figures 36 and 37).

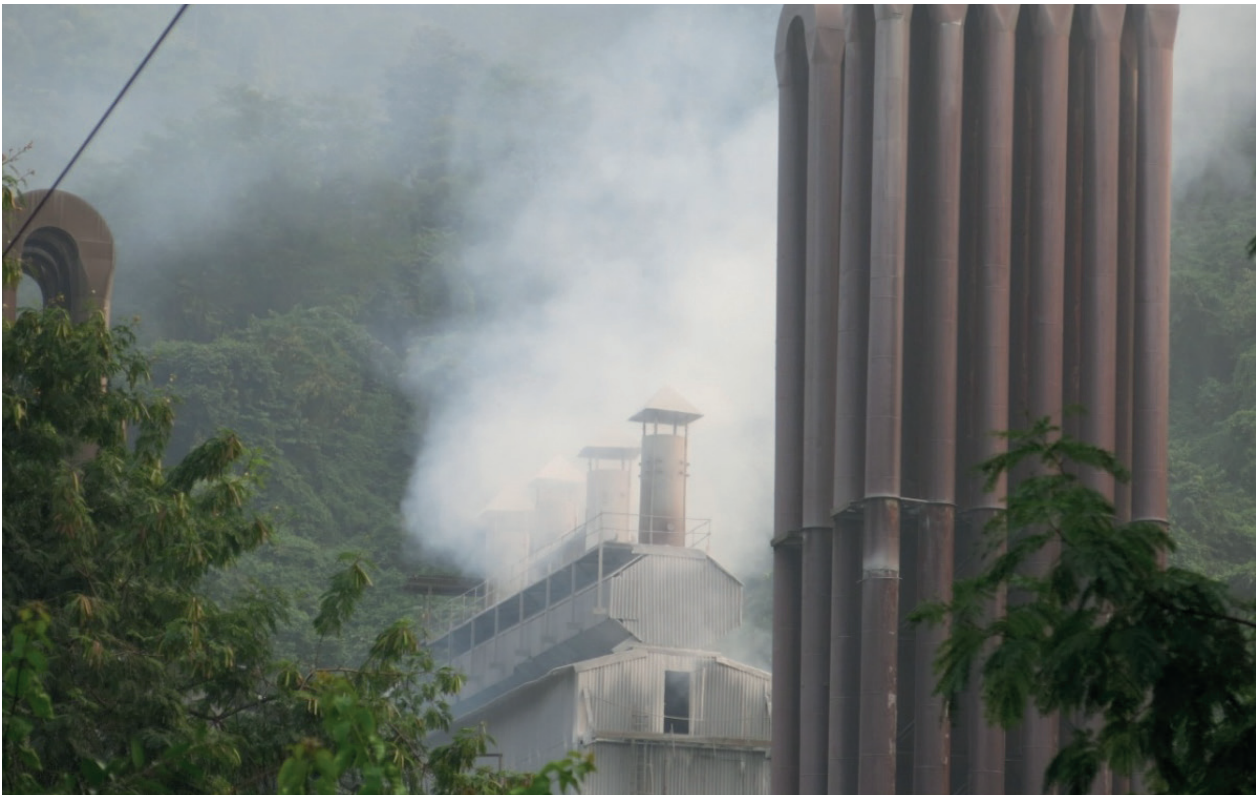
*Figure 33: Emission from point source during non-operation of Gas Cleaning Plant*

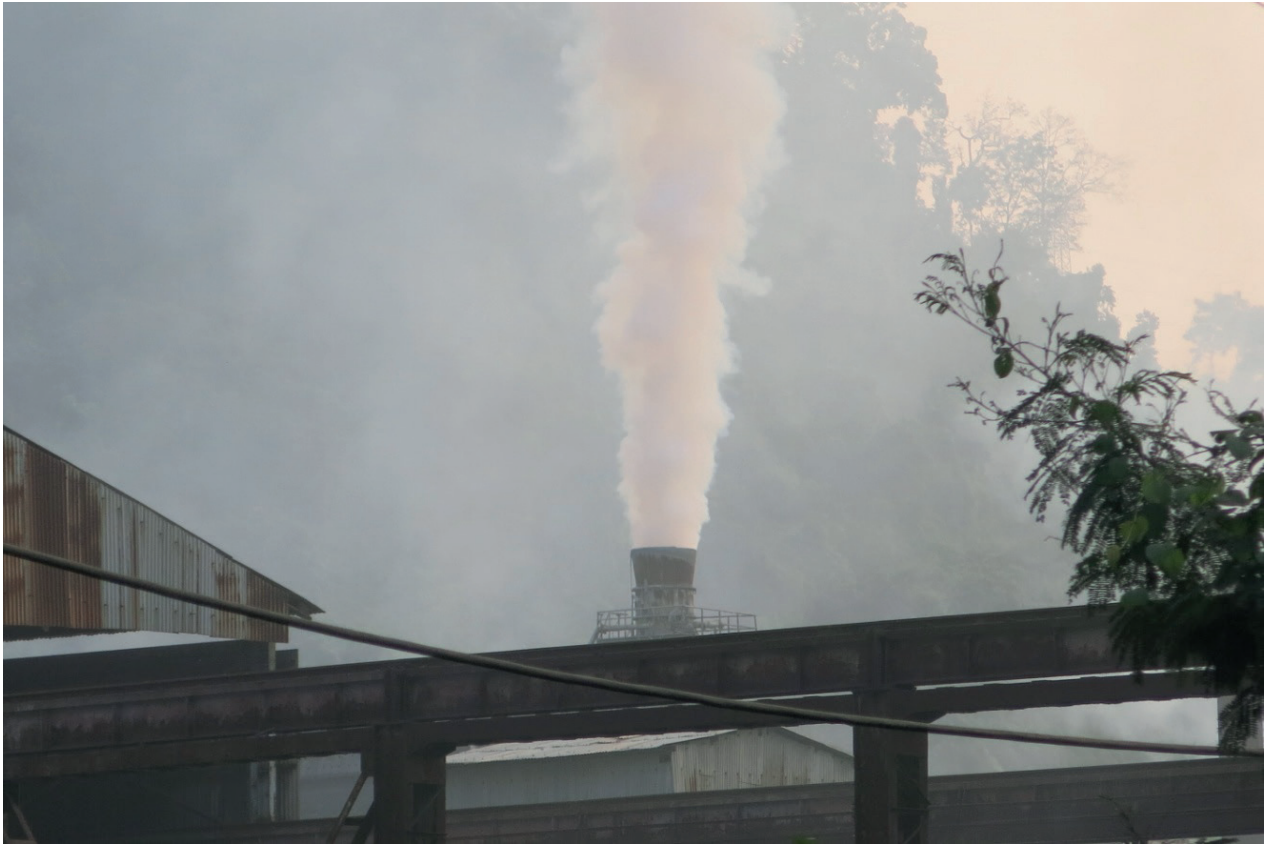
Figure 34: Emission from point source during non-operation of Gas Cleaning Plant

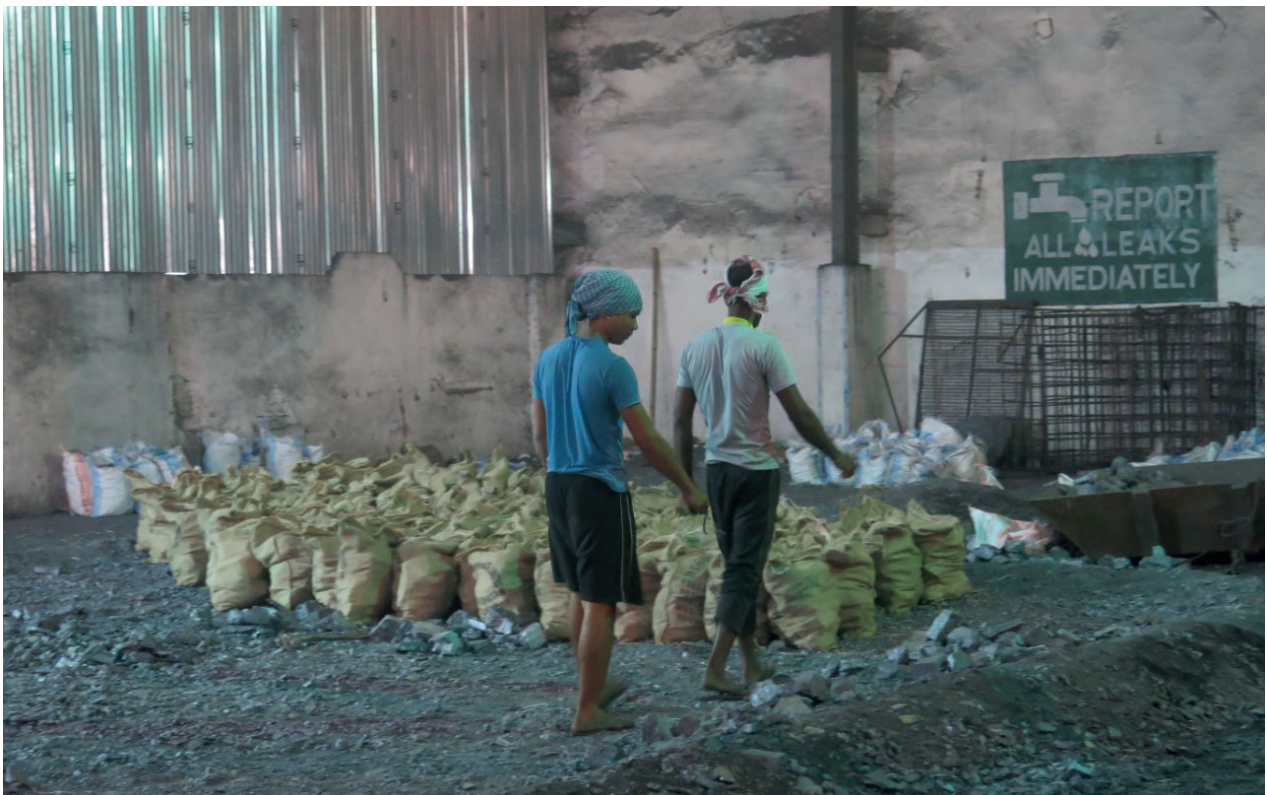
Figure 35: Workers working without any safety gears in most of the industries

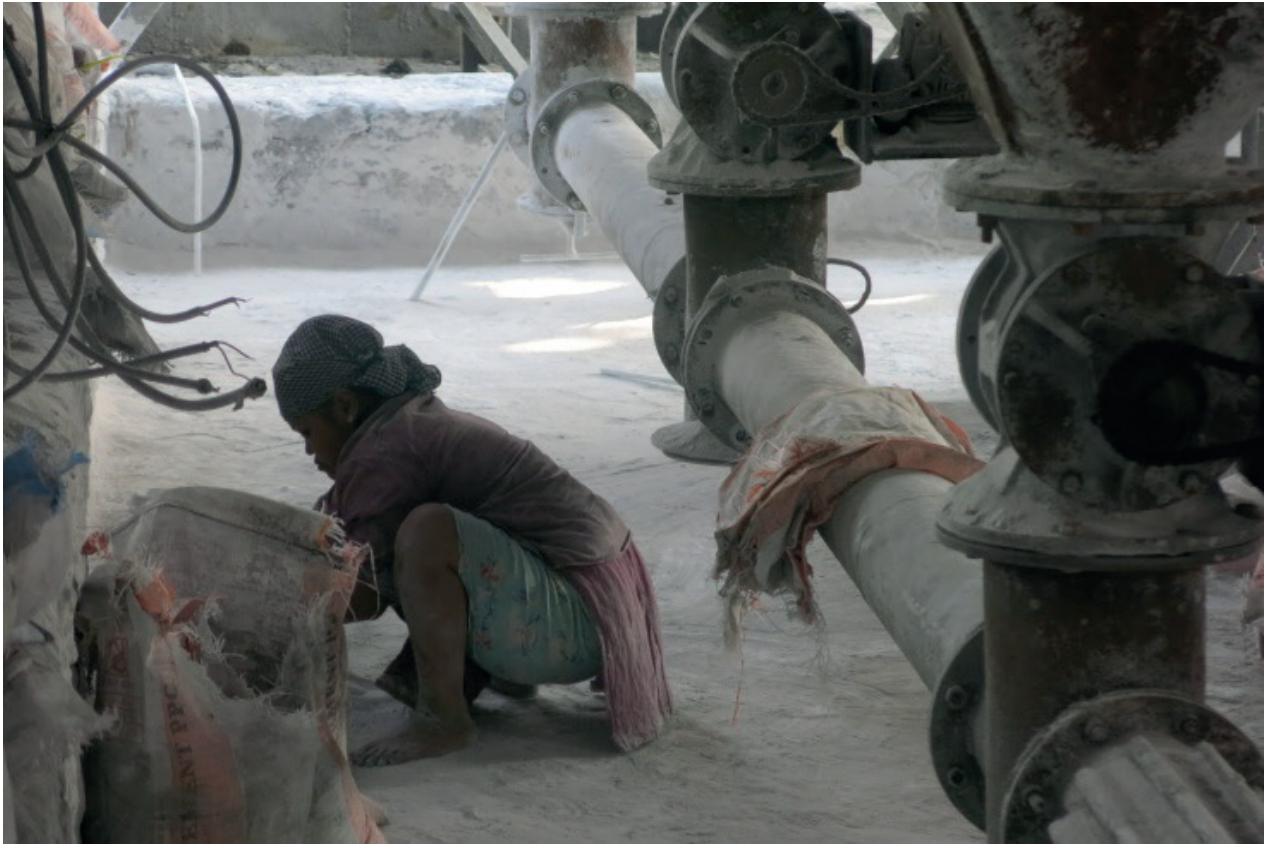
Figure 36: Manual dust collection in most of the industries
