DISCUSSION PAPER

TANZANIA

Development of Environmental Management
Strategy Towards Sustaining Ecological Integrity
of Lake Victoria

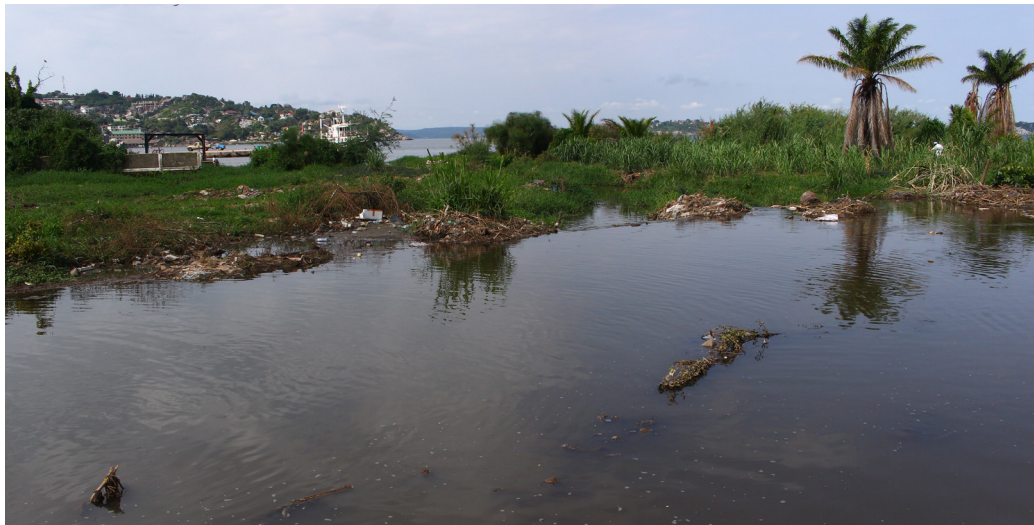
Image 1: Mirongo river discharging in Lake Victoria

It is important to mention that the Mirongo River is one of the seven major rivers of Tanzania that flows into Lake Victoria. It is an urban stream that flows through the central part of Mwanza city and empties its water into Lake Victoria. The river has a total stretch of approximately 8 km passing through some industrial

and among the most densely populated residential parts of the city. The city is partly serviced by a sewerage system which discharges about 5,000 cubic metres of raw sewage directly into the river on a daily basis. The report prepared under Lake Victoria Environmental Management project has also highlighted that the Mirongo River has turned into an open sewer transporting tonnes of industrial and municipal waste into Lake Victoria every year.⁹

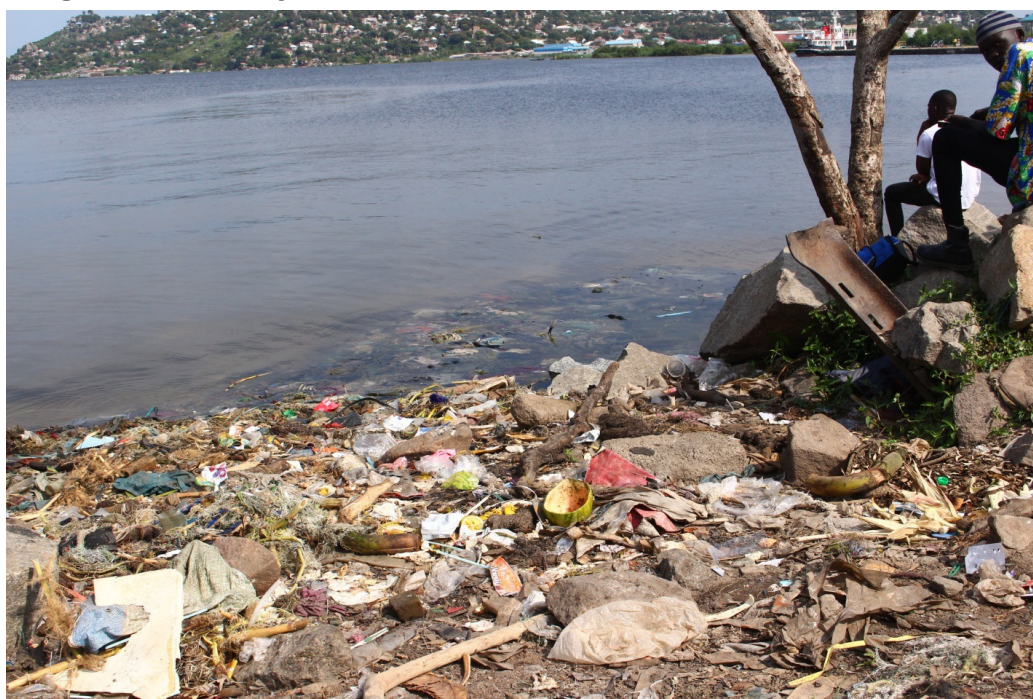
Image 2: Waste dumped at the shore

There has been a rise in settlements on the shores of the lake, especially of those communities involved in fisheries and livestock. This has led to an increase in waste generation, and in the absence of any waste collection system, all this waste is ultimately getting dumped into the lake. Visible litter on the banks of the river in the form of plastic and other solid waste can be easily observed, which, besides polluting the water body, also impacts the aesthetic look of the lake.
