REPORT

STATUS OF STONE CRUSHERS IN PUNE, MAHARASHTRA

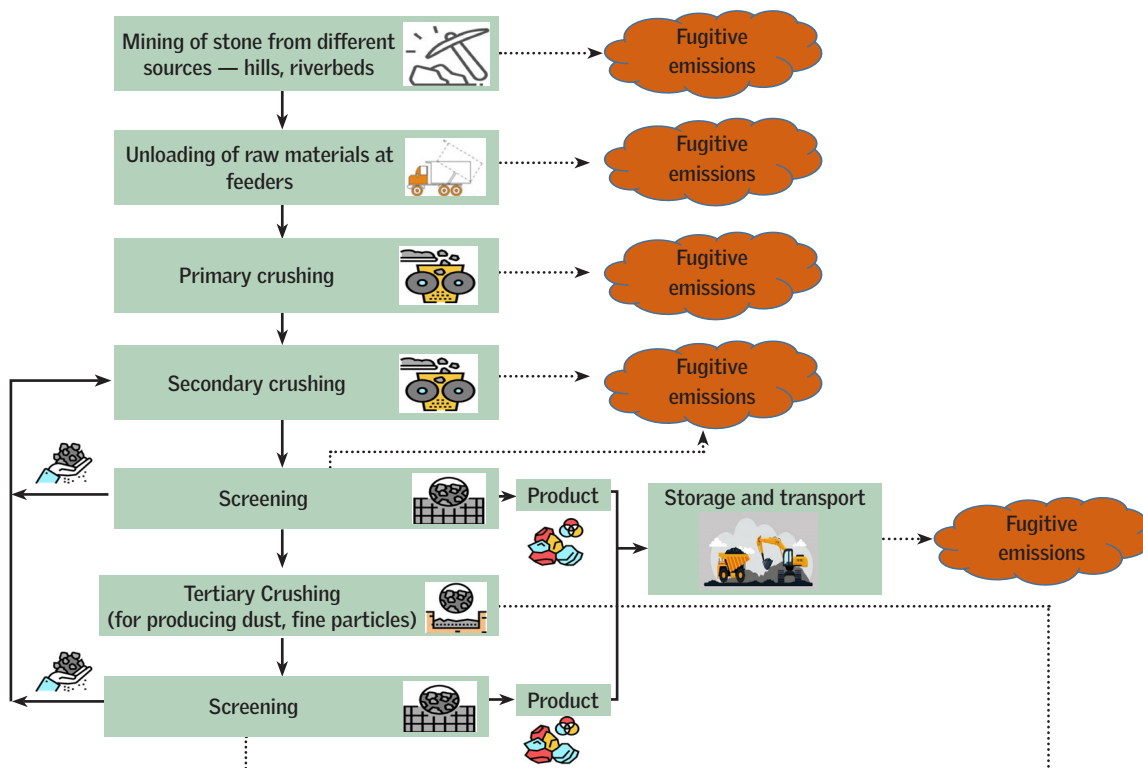
Figure 2: Manufacturing process and sources of emissions

The products from these units generally include fine dust and stones of sizes 6 mm, 10 mm, 20 mm and 40 mm. A different size of stone can also be produced as per the demand by changing only the size of the screen mesh. Fugitive emissions are generated from different processes in a stone-crushing industry (see *Figure 2: Manufacturing process and sources of emissions*).

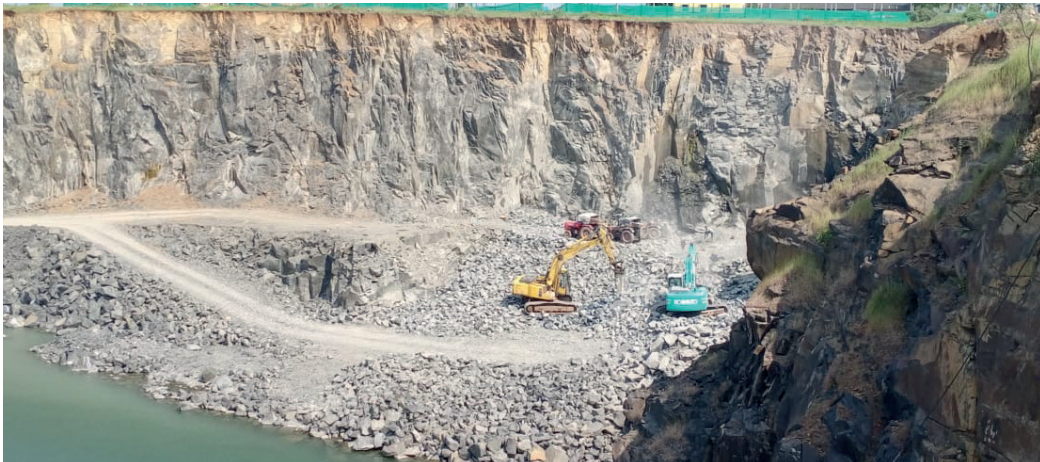
Image 1: Stone mining

- i. **Mining of stone:** Mining is the initial step to get the raw material from different sources like local hillocks, open-cast mines, riverbeds, cliffs and other miscellaneous sources. Usually, small-sized stone crushers source their raw materials from local hillocks, riverbeds or from mine owners in the vicinity, while medium- and large-sized units source their raw materials from leased or owned open-cast mines. During stone mining at quarries, a huge amount of fugitive emission is generated and clouds of dust can be seen.

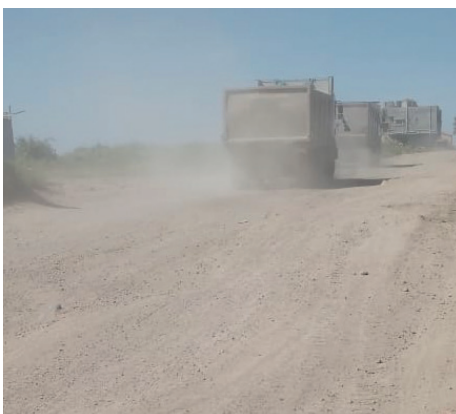
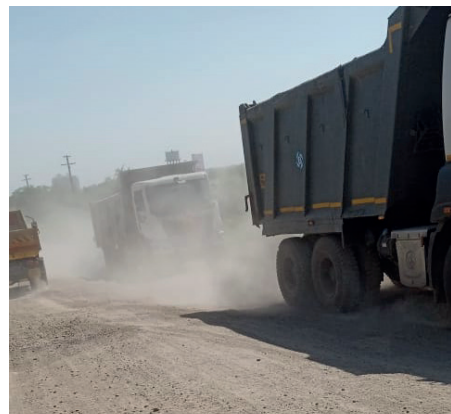
Image 2: Raw materials transported in trucks

- ii. **Transportation of raw materials:** Mined stones from various sources are transported to stone-crushing units via trucks, trailers and automatic dumpers. While transporting raw materials to the crushing sites, these vehicles generate a huge amount of dust emissions because the roads are mostly unmetalled and uncemented.

2a. Trucks carrying material to crushers

2b. Trucks creating fugitive emissions

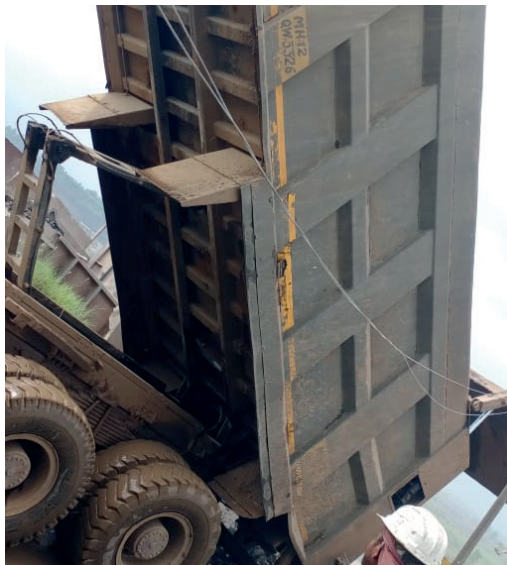
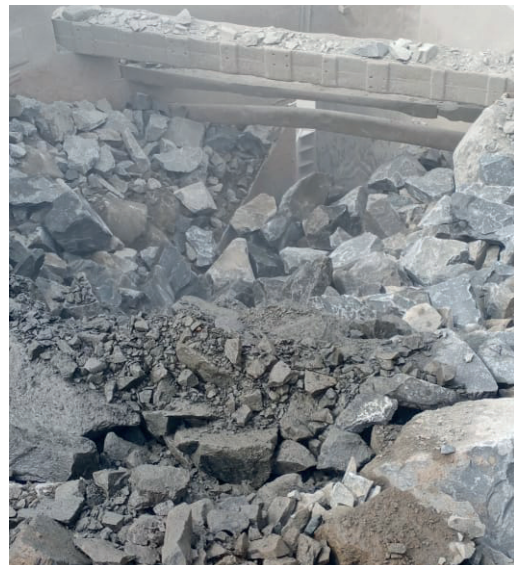
Image 3: Unloading of raw material into feeders

iii. Unloading of raw materials at feeders: Raw material is transported to stone crushers through various vehicles, most of which have hydraulically operated tilting arrangements for easy and quick unloading of stones at the crusher sites. The unloading of raw materials is done at feeders or hoppers. In the course of unloading raw materials at hoppers or feeders, dust emissions are generated.

3a. Trucks unloading the raw material

3b. Unloading of material through trucks in feeders

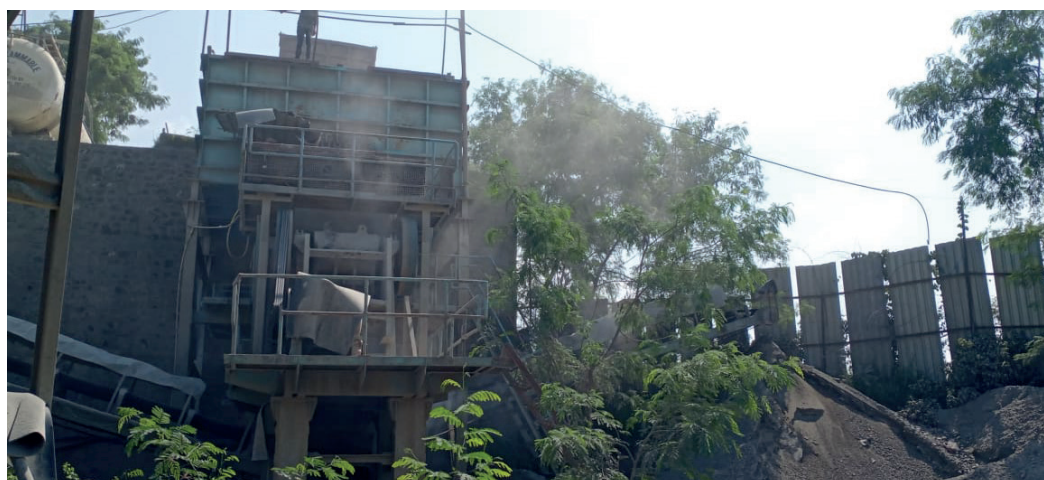
Image 4: Primary crushing and emissions released from it

iv. Primary crushing: Size reduction is done in the process of primary crushing. Large stones and boulders are crushed into stones of 100–140 mm. Crushed stones are conveyed to stockpiles to further transfer them to secondary crushers via conveyor belts. During primary crushing, the finer dust particles enter the air and escape as fugitive emissions.

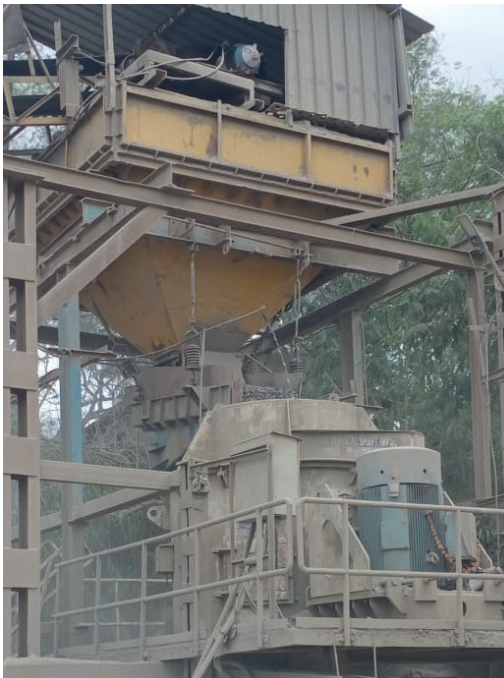
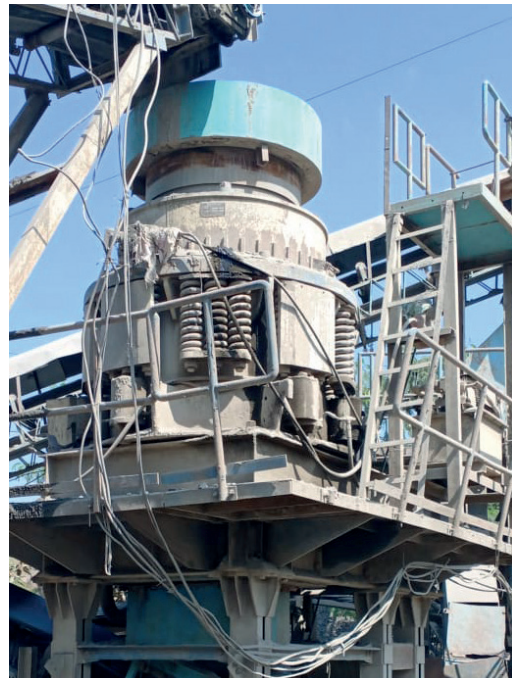
Image 5: Secondary crushing section

- v. **Secondary crushing:** After primary crushing, stones are further crushed to sizes ranging from as large as 40–60 mm to 10 mm or even smaller. Stone-crushing units use different types of crushers for secondary crushing. The granulator is most commonly used in non-engineered units (with basic design) while engineered units use a cone crusher for this process. A lot of fugitive emissions are generated during secondary crushing as well.

5a. Emissions at secondary crushing

5b. Cone crusher for secondary crushing

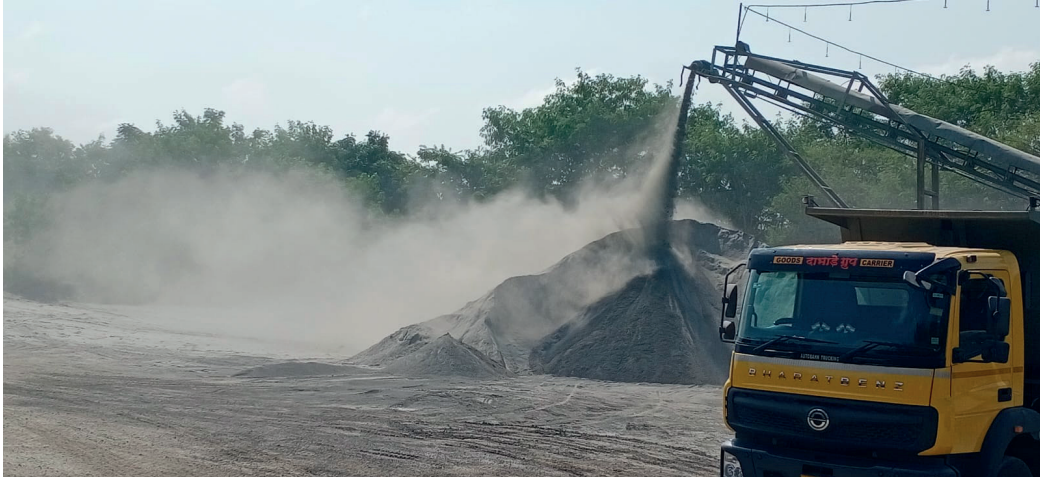
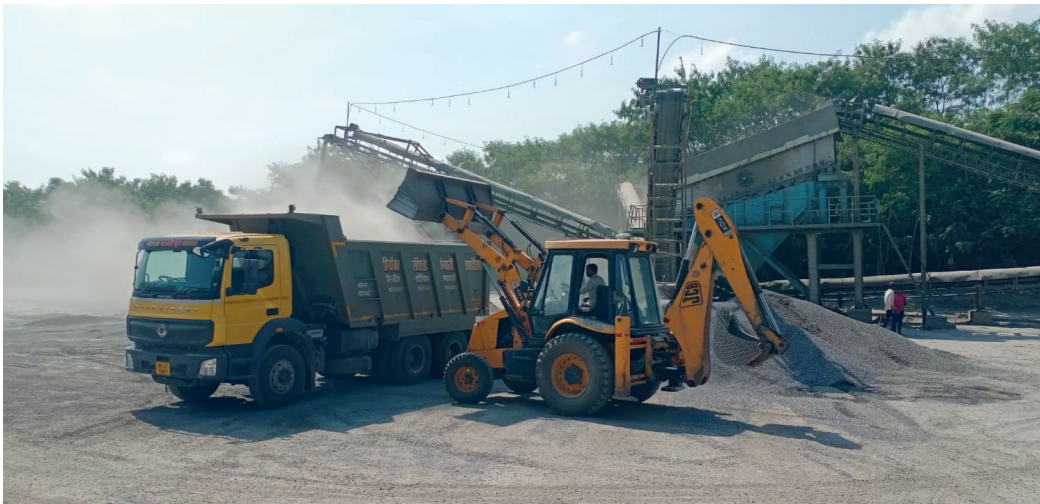
Image 8: Fugitive emissions released during product storage and loading

viii. Product storage and loading: After tertiary crushing, the products are transferred through chutes, and direct disposal of the product onto the stockpile generates high amounts of fugitive emissions (see *Image 8a. Fugitive emissions generated during the transfer of product*). After the product is transferred through chutes onto the stockpiles, it is loaded onto vehicles for transportation. During the loading of the product onto trucks, a lot of fugitive emissions are generated (see *Image 8b. Fugitive emissions generated at the time of loading of product*). It has been observed that, more often than not, trucks carrying such fine sand neither provide any cover on the top nor make the sand wet to prevent fugitive emissions.

8a. Fugitive Emissions generated during the transfer of product

8b. Fugitive emissions generated at the time of loading of product

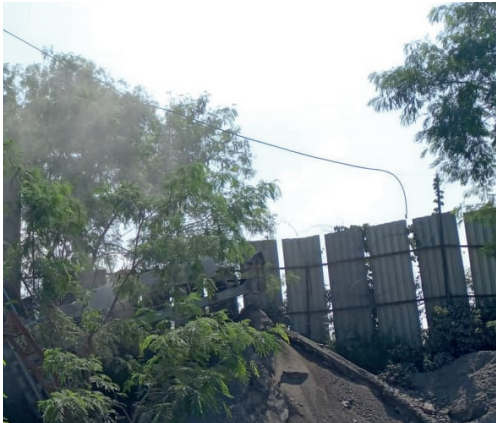
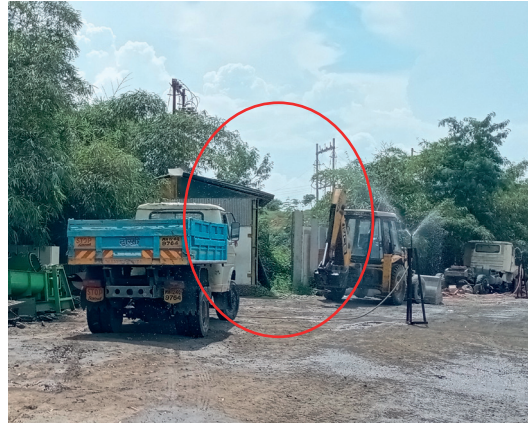
Image 9: Conditions of wind-breaking walls

As per the survey conducted by the CSE team, it was found that around 97 per cent of the stone-crushing units have gaps in the wind-breaking walls, which also do not have a strong structural base and are not adequately designed. Gaps or spacing between the wind-breaking walls allow the dust to pass outside the unit, from where it spreads to farther locations. The wind breakings walls were welded with steel rods, joined with steel wires, and had a shallow depth of foundation. As discussed with the owners and workers of the stone crusher units, during bad weather conditions, these wind-breaking walls often topple down.

9a. Gaps between wind-breaking walls

9b. Wind-breaking wall of inadequate height

In order to resist the wind load and reduce the risk of structural damage from wind, it is necessary to reinforce the existing walls or build a strong structural base. In addition to this, most of the wind-breaking walls were inadequately designed,

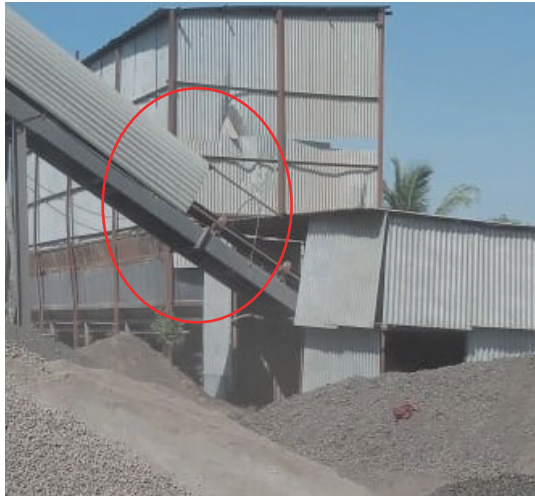
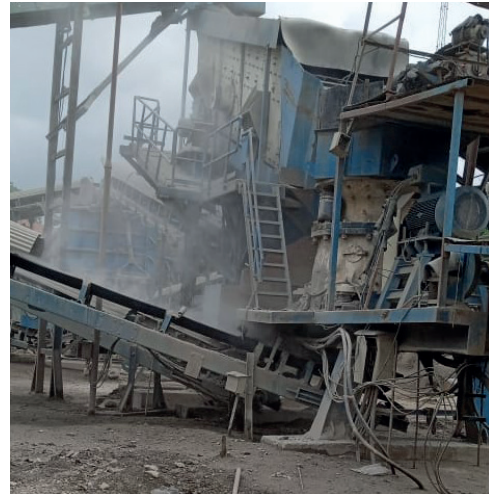
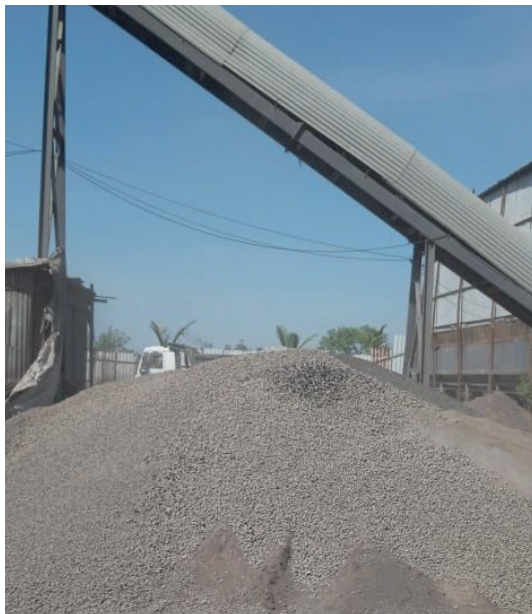
Image 10: Conditions of conveyor belts and water sprinkling system

As per the survey conducted by the CSE team, it was found that only 31 per cent of the units are fully covered from node to node and the remaining 69 per cent of the surveyed units have partially covered (open at some locations) conveyor belts.

In addition to this, suitable location of water sprinklers at the conveyor belts and the correct timing of their operation can also help in decreasing fugitive emissions in stone-crusher units. However, during the survey, the CSE team observed that water sprinklers in 73 per cent of the units were not in working condition during the survey period and only 27 per cent of units had water sprinklers in working condition installed at the conveyor belts.

10a. Partially covered conveyor belts

10b. Uncovered conveyor belts

10c. Fully covered conveyor belts

10d. Sprinklers not working at belt

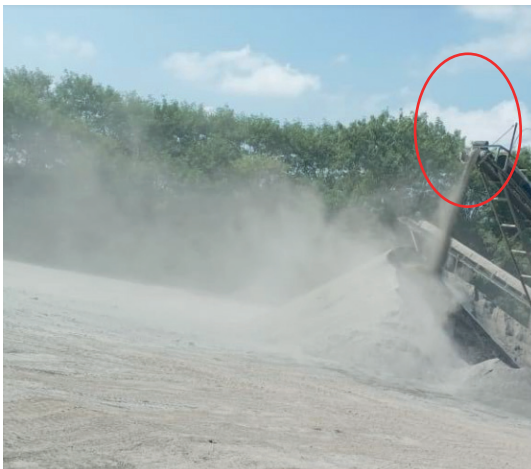
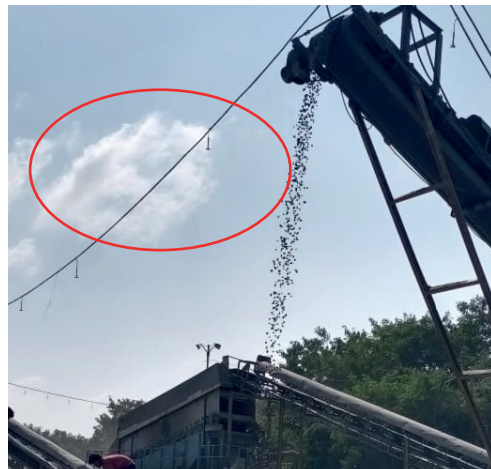
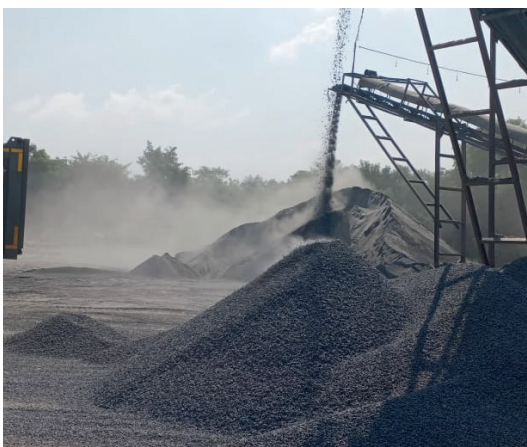
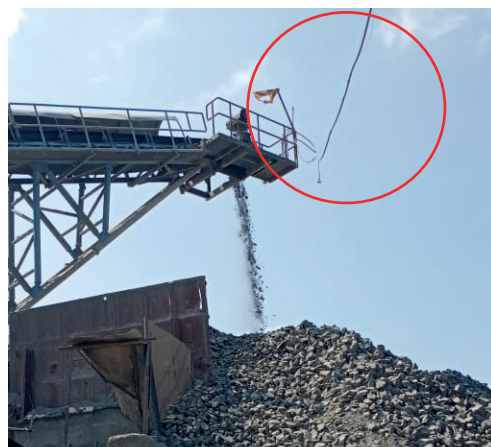
Image 11: Water sprinklers near the heaps

As per the survey conducted by the CSE team, it was found that around 47 per cent of the units do not have water sprinklers around the heaps, in 40 per cent of units they have installed water sprinklers but they were not in working condition and only 13 per cent of the units had sprinklers which were in working condition.

11a. Sprinkler not working near dust heap

11b. Sprinkler not working near aggregate

11c. Fugitive emissions near heaps

11d. Water sprinkler not working at heaps

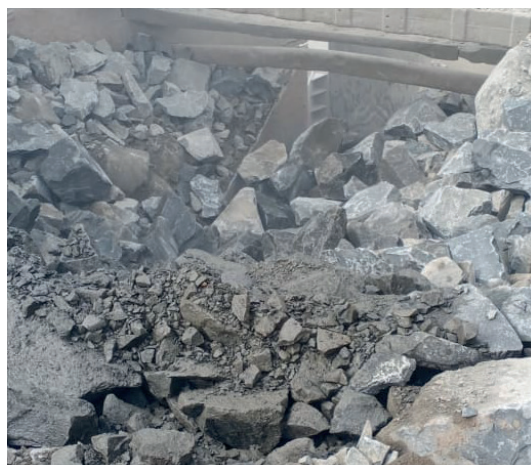
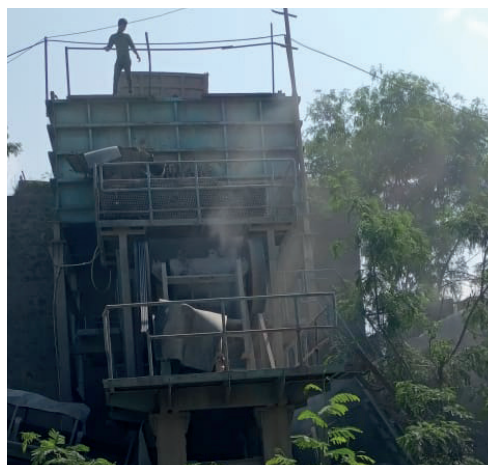
Image 12: Highlights of hoppers in a stone crusher unit

The survey revealed that many of the stone-crushing units have installed water sprinklers in the hopper section, but they were not operational. It was also found that 7 per cent of the units do not have any covering around the hoppers, in 73 per cent of the surveyed units the hoppers are partially covered and have water sprinklers, and only 20 per cent of the units have fully covered hoppers with M.S. or G.I. sheets and have proper water sprinkling arrangements.

12a. Hopper at stone crusher unit

12b. Water sprinkler not working at hoppers

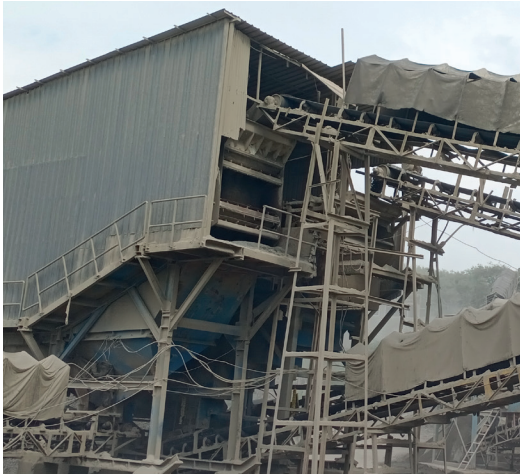
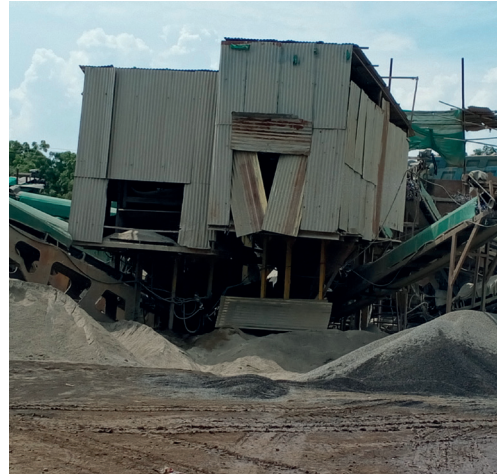
Image 13: Highlights of the screening section at stone crusher units

During the survey conducted by the CSE team, it was found that around 7 per cent of the units do not have any covering on the screen section, in 73 per cent of the surveyed units screen equipment is partially covered with sheets, and only about 20 per cent of the units have fully covered screens with M.S. or G.I. sheets and proper door arrangement for maintenance.

13a. Screen with door arrangement

13b. Screen with inadequate covering

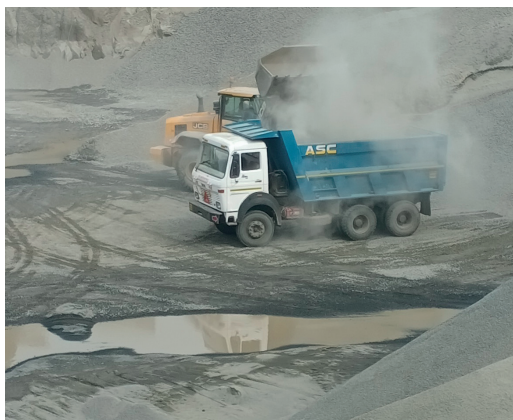
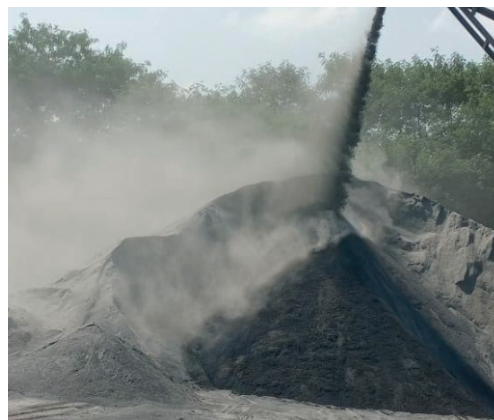
Image 14: Highlights of the products stored at stone crusher units

During the survey conducted by the CSE team, it was found that none of the units are storing the material in silos and they do not have telescopic chute arrangements

14a. Product stored in open spaces

14b. Fugitive emissions at product release

for releasing the products from the discharge point. The final product, such as aggregates of different sizes and dust, was being stored in open spaces.

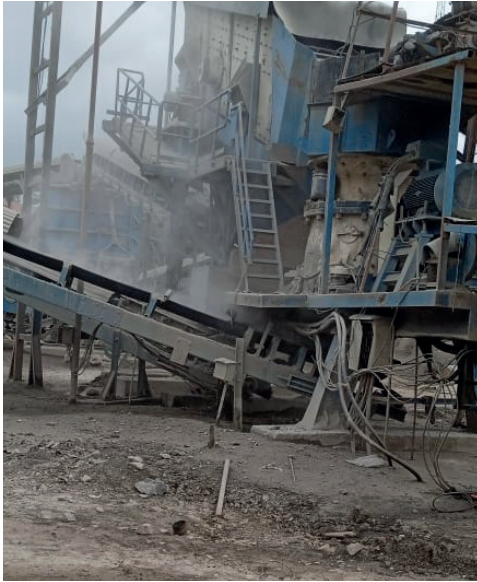
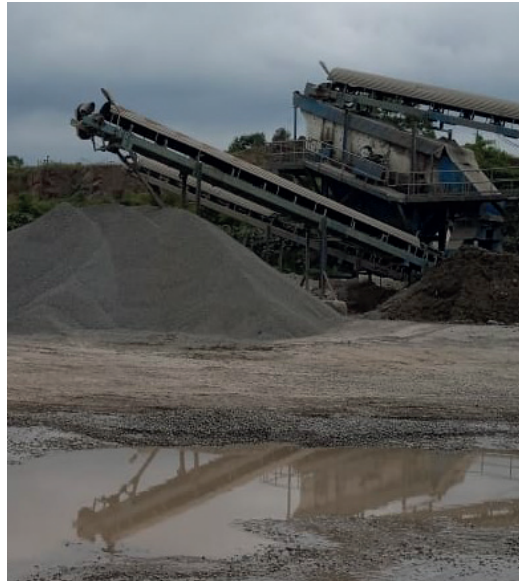
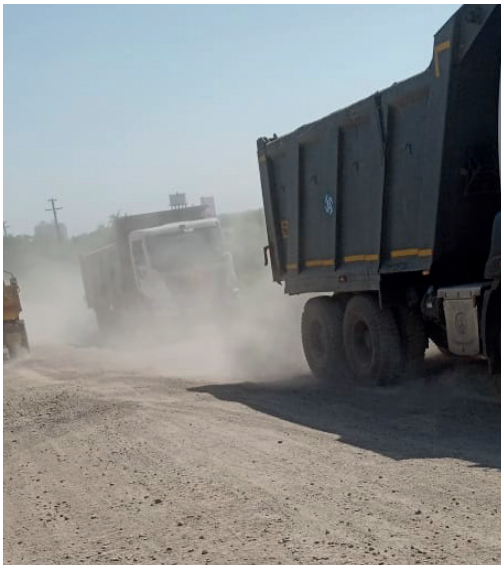
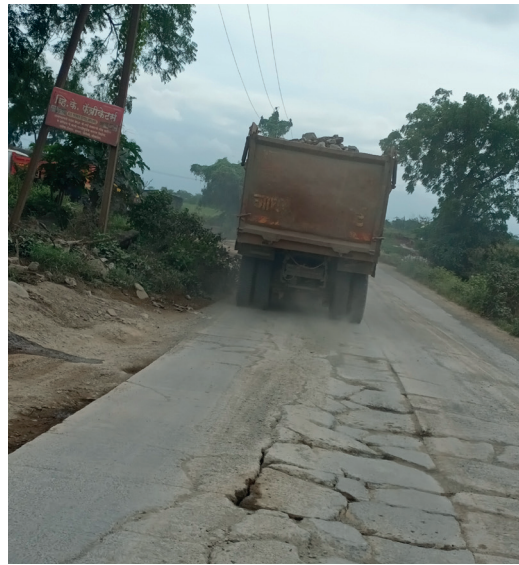
Image 15: Conditions of roads in stone crusher zones

With regard to road infrastructure within and outside the crusher zone, the condition in Wagholi as well as in Lonikand village was questionable or worse. During the survey, the CSE team found that many stone crusher units did not have adequate road infrastructure. It was found that none of the units have a regular mechanism for cleaning the roads, and the black concrete top of the roads was not visible due to being covered with dust, which highlights the scale of fugitive dust emissions generated in a stone crusher.

In addition to this, it was also seen that heavy vehicular moment has damaged the road infrastructure and there is no maintenance. It can be seen that the guidelines and recommendations are not being implemented on the ground.

15a. Broken roads inside crusher unit

15b. Roads filled with water inside the crusher

15c. Dust emission due to heavy vehicles

15d. Broken roads due to heavy vehicles

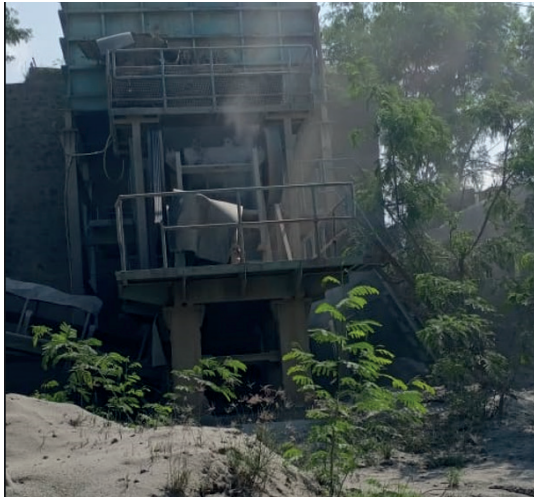
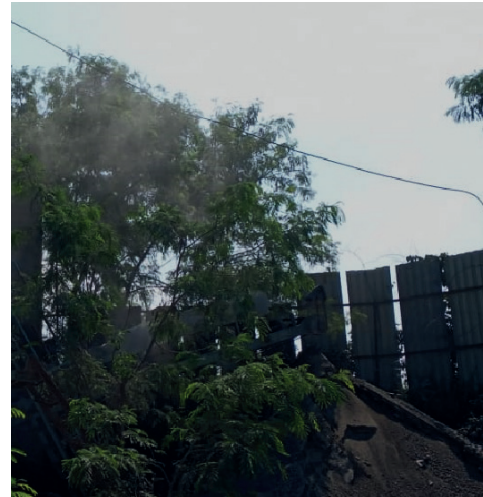
Image 16: Green cover in stone crusher units

While conducting the survey, the CSE team found that only 20 per cent of the surveyed units have proper coverage of trees and the remaining 80 per cent of the surveyed units have a partial covering of trees of inadequate height around the periphery, which would not be able to act as a barrier against dust emissions.

16a. Plantation without scientific planning

16b. Trees of inadequate height

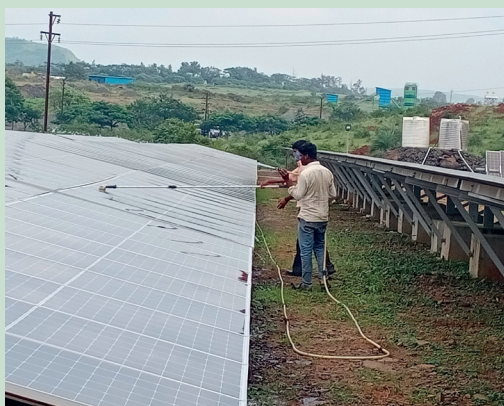
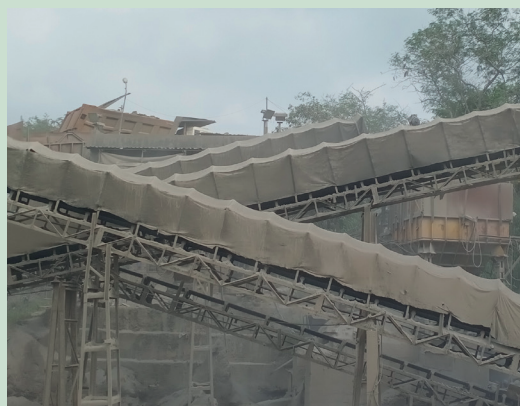
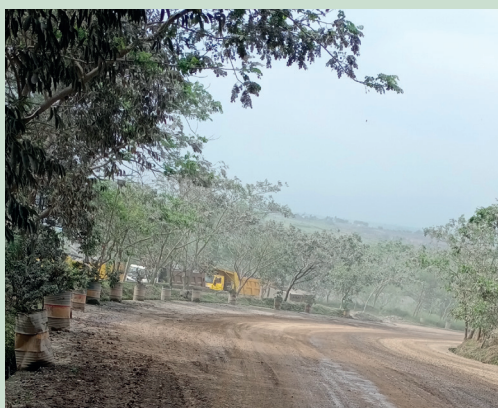
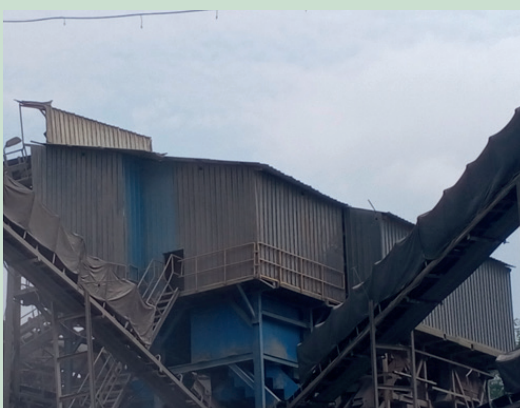
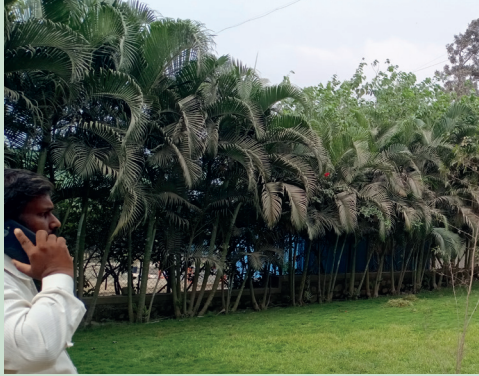
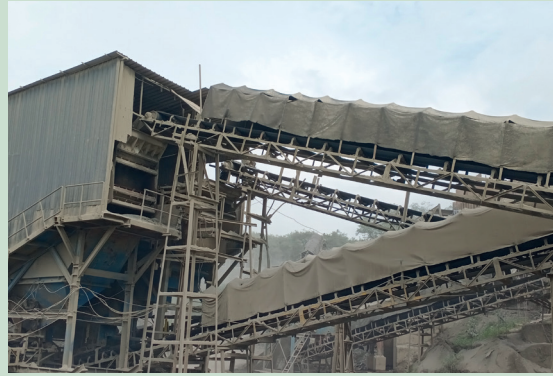
Image 17: Best operating practices in a stone crusher in Pune

During the survey conducted by the CSE team, it was observed that the conveyor belts in the stone crushers were covered with sheets to reduce fugitive emissions. Water sprinklers were made available at all the strategic locations such as loading, unloading, crushing, conveyor belt and entry points. It was also observed that all three crushing sections were covered with G.I./M.S. sheets.

During the visit, the CSE team also observed that the unit has a thick foliage of plants along its periphery. The trees were around 20 metres high and the green belt had a width of around 5 metres.

17a. Cleaning of solar panels

17b. Covered Conveyor belts

17c. Regular wetting of the road

17d. Covered screen with door arrangements

17e. Thick foliage of plant along the periphery

17f. Covered secondary crushing units
