INFUSING NEW LIFE

**Gaps and challenges in managing lakes and
ponds and groundwater in four selected
AMRUT cities of Uttar Pradesh**

Citation: Sushmita Sengupta, Pradeep Kumar Mishra, Swati Bhatia, Vivek Kumar Sah and Mehak Puri 2024, *Infusing New Life: Gaps and Challenges in Managing Lakes and Ponds and Groundwater in Four Selected AMRUT Cities of Uttar Pradesh*, Centre for Science and Environment, New Delhi

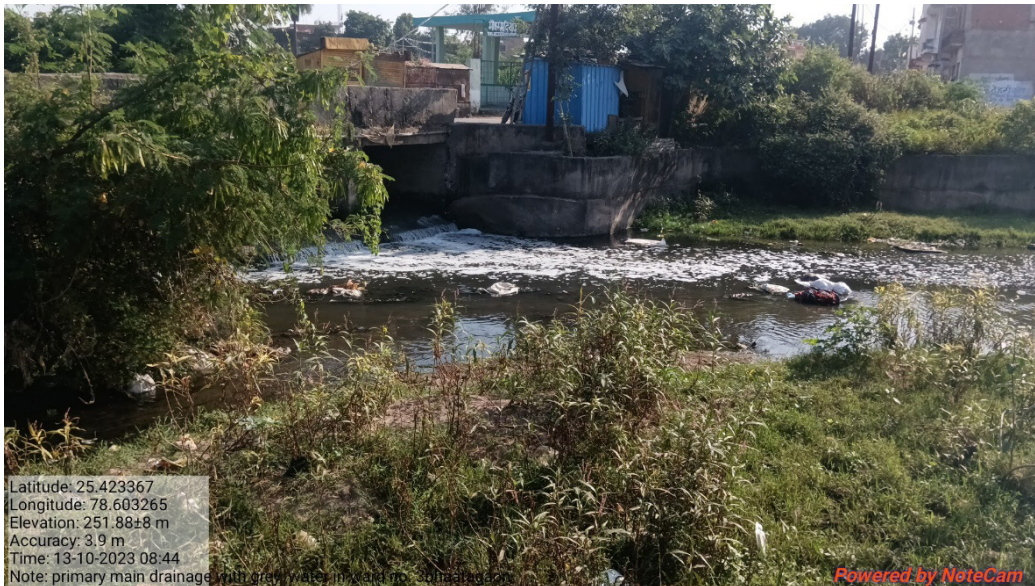
After every shower, the storm-water drains of ward number 3 in Jhansi overflow. The drains carry a cocktail of water and wastewater. The drains are also clogged at places due to rampant dumping of solid waste. This clogging of drains is a common feature in all the wards of the city.

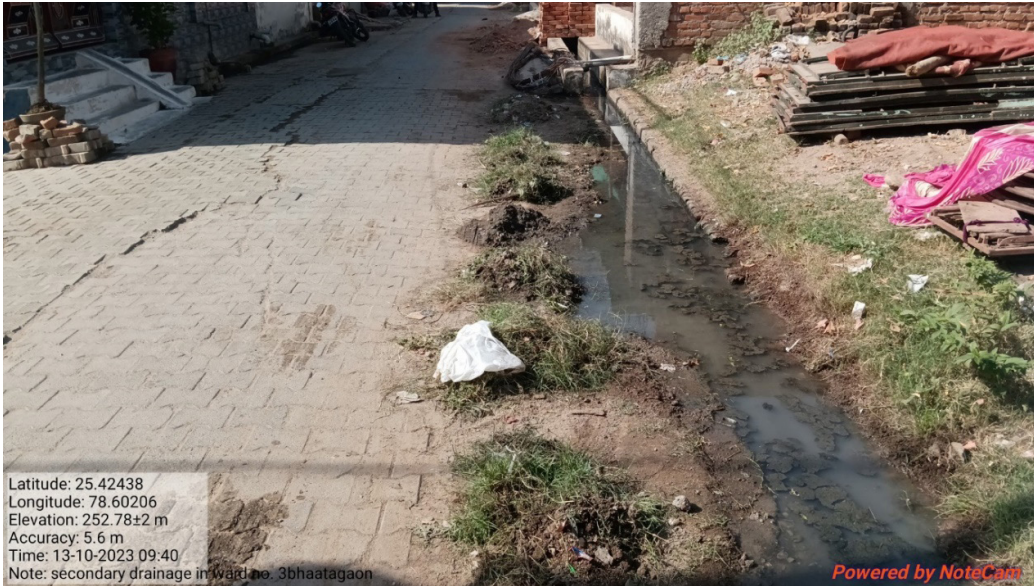
The storm-water drains in most of the wards of Jhansi are poorly built and broken, and spill over even after light showers

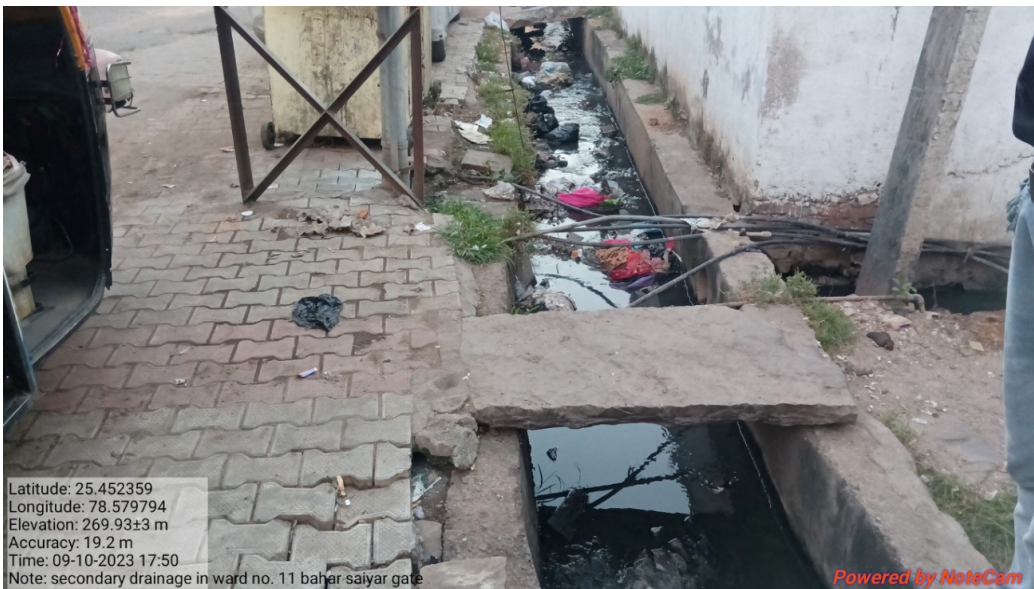
There is no management of the solid waste in the city. Solid waste is dumped everywhere, including in storm-water drains. The drain in ward number 11 is a good example of drains choked with solid waste, especially plastics.

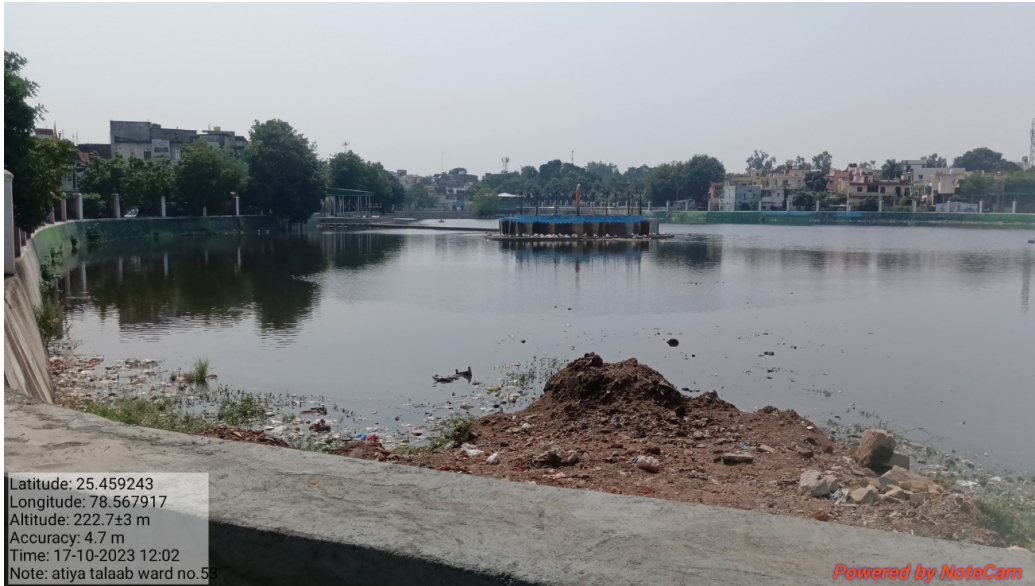
Latitude: 25.459243
 Longitude: 78.567917
 Altitude: 222.7±3 m
 Accuracy: 4.7 m
 Time: 17-10-2023 12:02
 Note: atiya talaab ward no.5

Solid waste is dumped along the periphery of Atiya lake, in the northern part of the city. The government has focused on beautification of the lake, and a peripheral boundary as well as a fountain have been created inside the lake. But low community awareness has affected the water quality of the lake. The people residing near the lakes regularly dump their waste there.

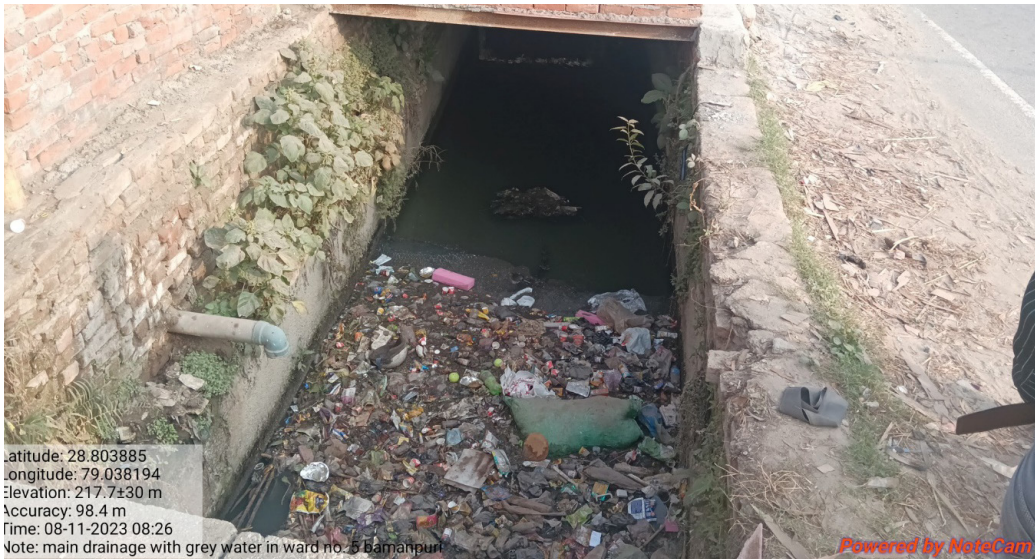
Plastic waste and wastewater are dumped in large and small drains in Rampur. Ward number 5 of the locality Bamanpuri is an example of how the drains look in the dry period—November—when water flow in the drain is low. During the monsoon, similar drains in almost all the wards overflow and flood neighbouring areas.

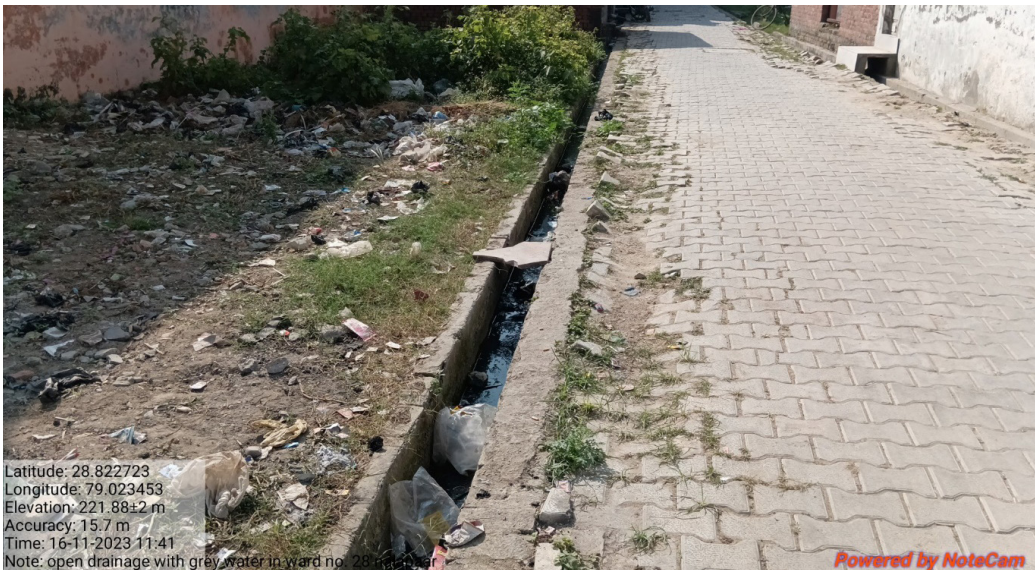
The narrow undersized drains in the Nalapaar area (ward number 28) of Rampur are choked with plastic, and greywater from households flows unabated into the drains. Spilling of wastewater is a common issue in the area after the rains.

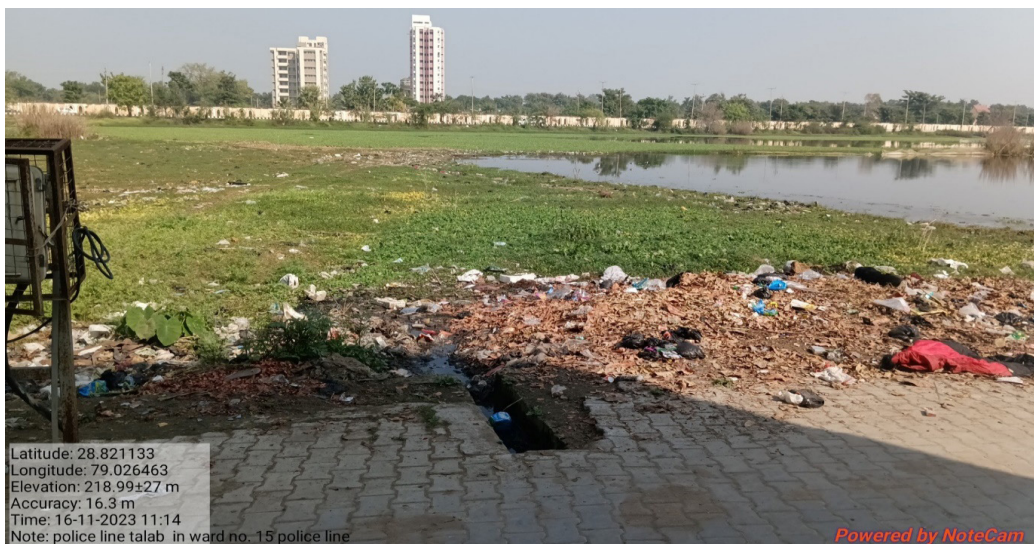
Greywater from households flows through a storm-water drain into the Police Line talab in ward number 15 of Rampur. People living in the vicinity dump solid waste in and around the talab.

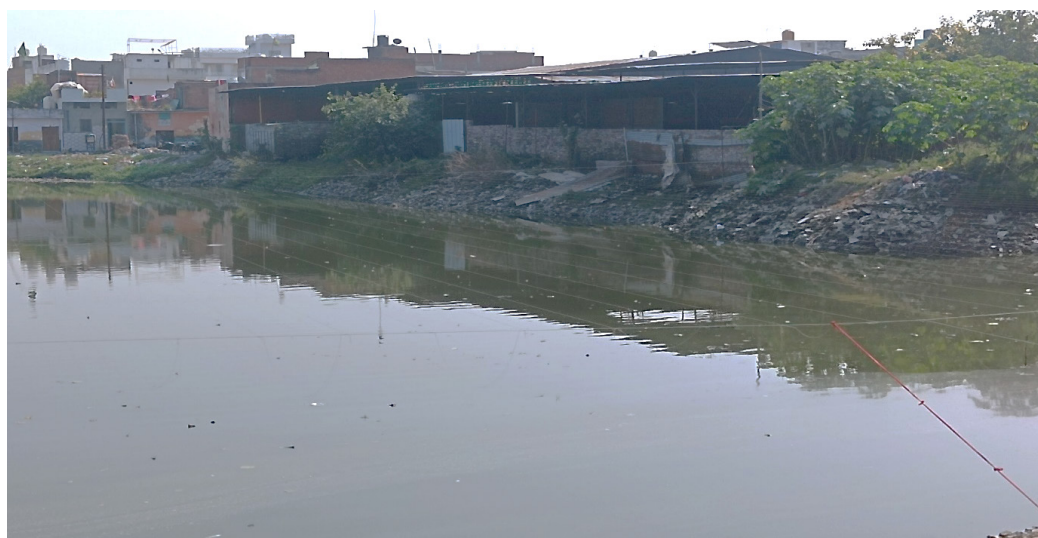
Nalapaar talab in Rampur is encroached on by illegal settlements. Wastewater from these settlements flows freely into the talab. The water stinks and is visibly black.

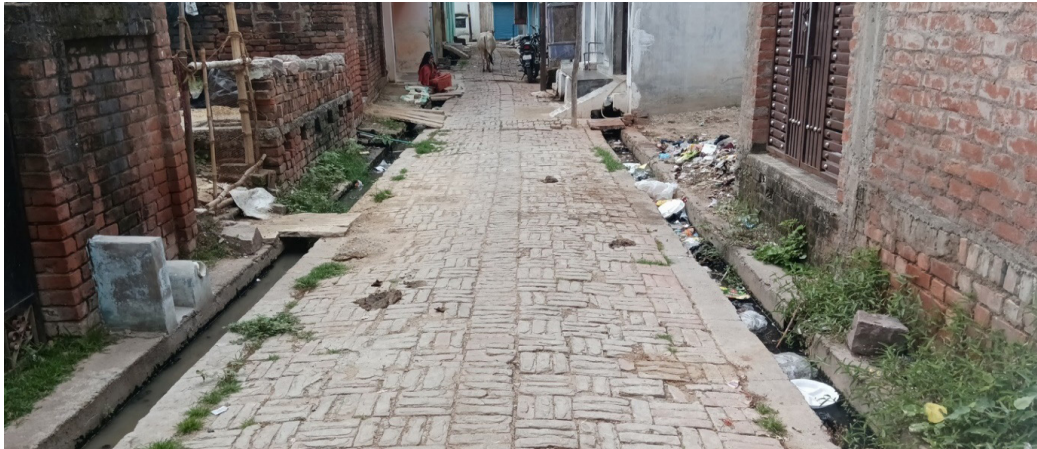
The narrow drains on both sides of the bricked road in ward number 10 of Banda are clogged with plastics. Greywater from households also flows into the same drains.

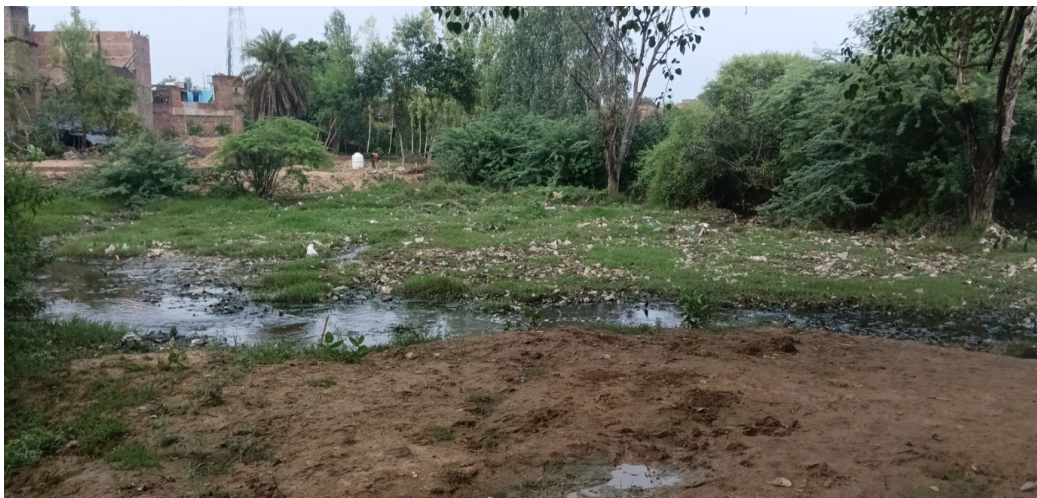
Wastewater, overflows from the neighbouring poorly designed storm-water drains floods the roads in August in Banda's ward number 15.

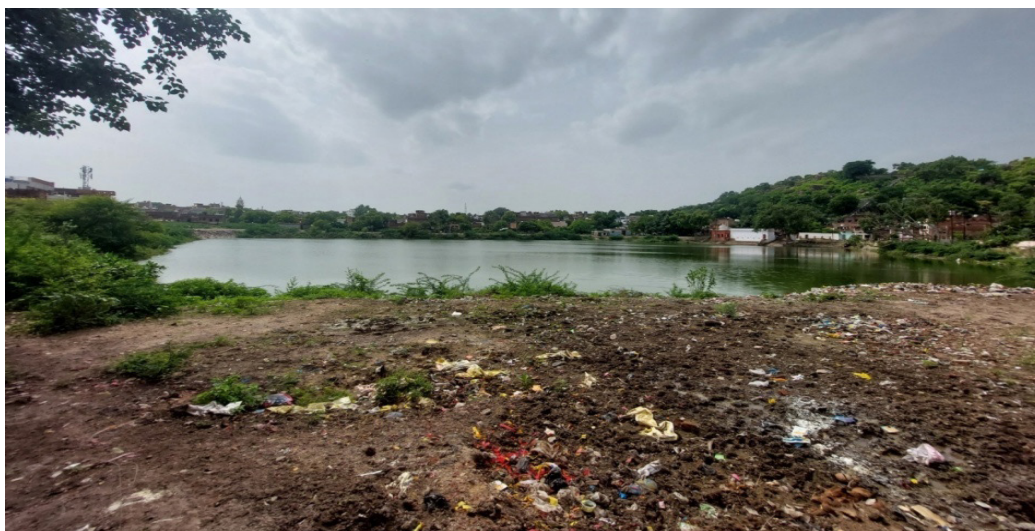
The talab in ward number 12 in Banda receives wastewater from surrounding households through storm-water drains. Solid waste is also dumped in and around the waterbody.

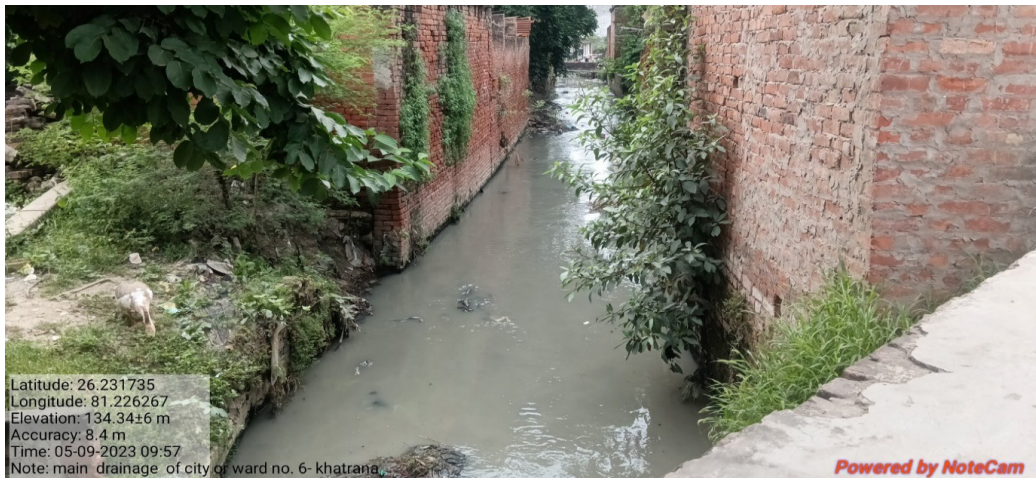
The main drain of the city flows through ward number 6 of Jhansi. A cocktail of water and wastewater flows through this drain and empies into the waterbody nearby.

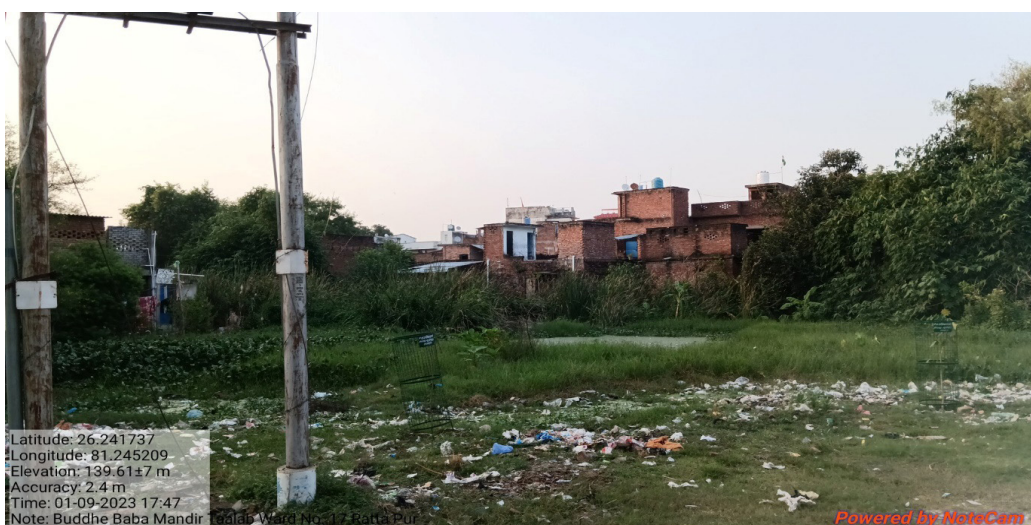
Solid waste is dumped on the waterbody of ward number 17 of Rae Bareli and it is almost completely encroached on. Only 10 per cent of the waterbody is filled with water; most of it is filled with sewage.

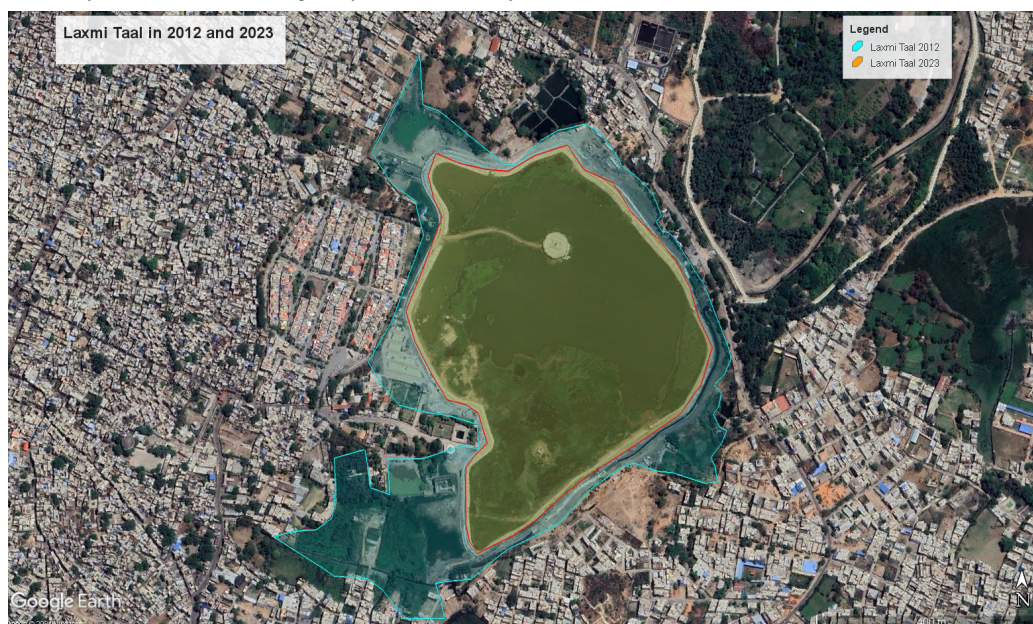
Water spread area reduced by 60 per cent as compared to 2011

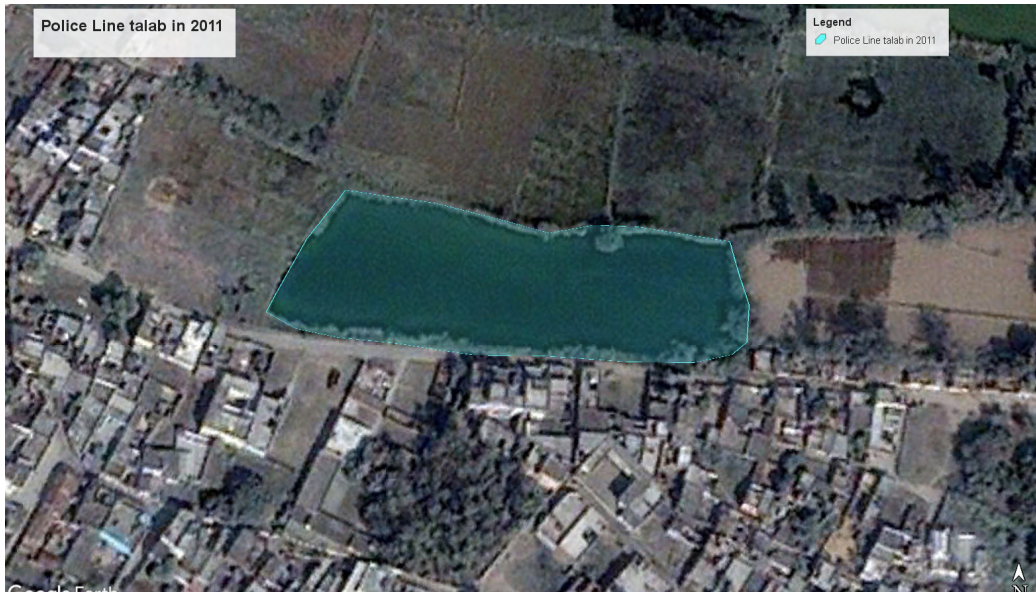
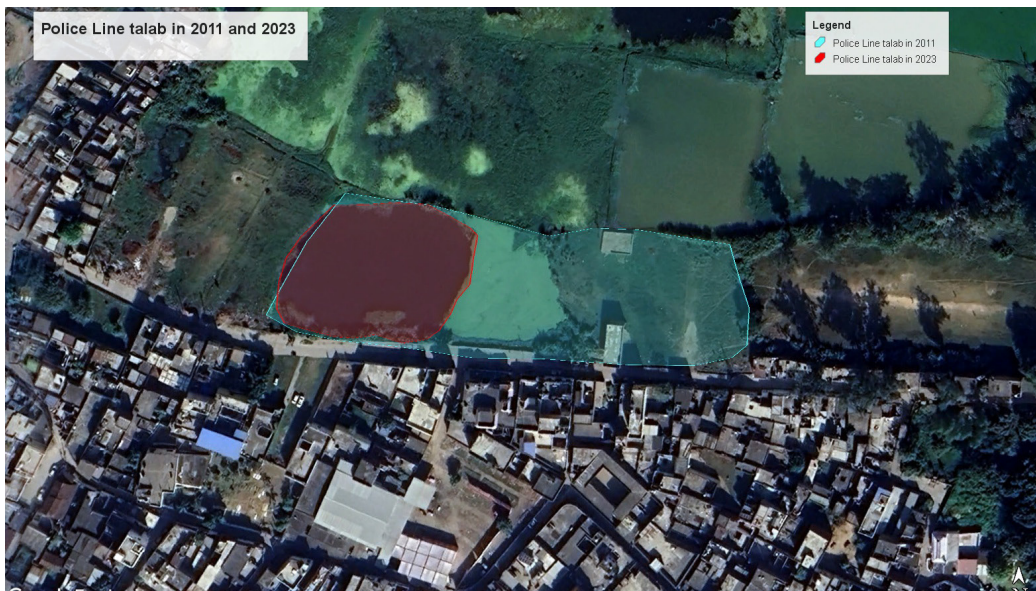
Water spread area has reduced by 44 per cent between 2011 and 2023

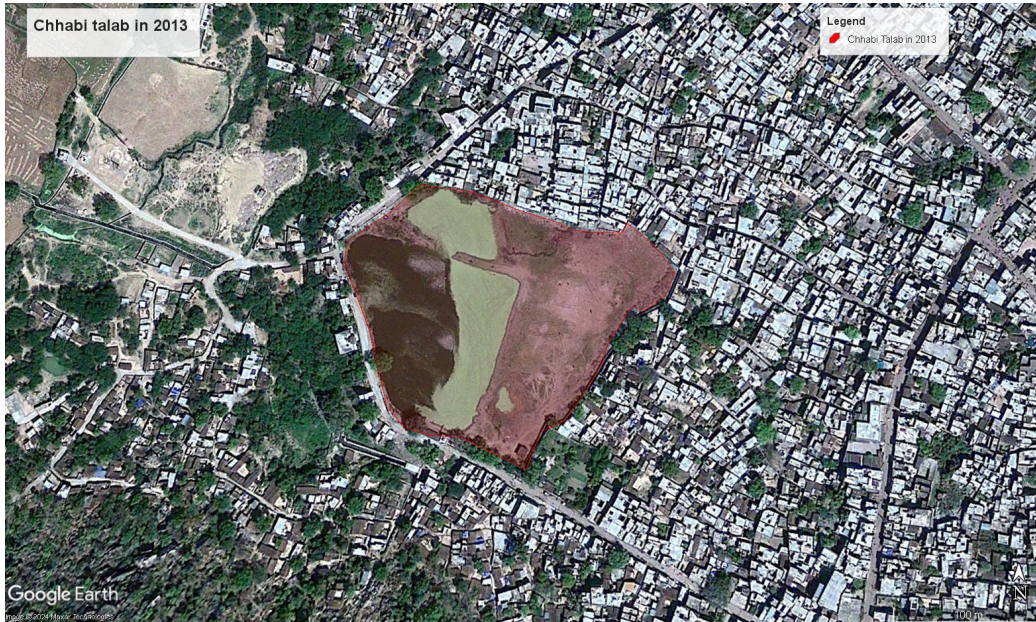
Water spread area has reduced by 22 per cent between 2013 and 2023

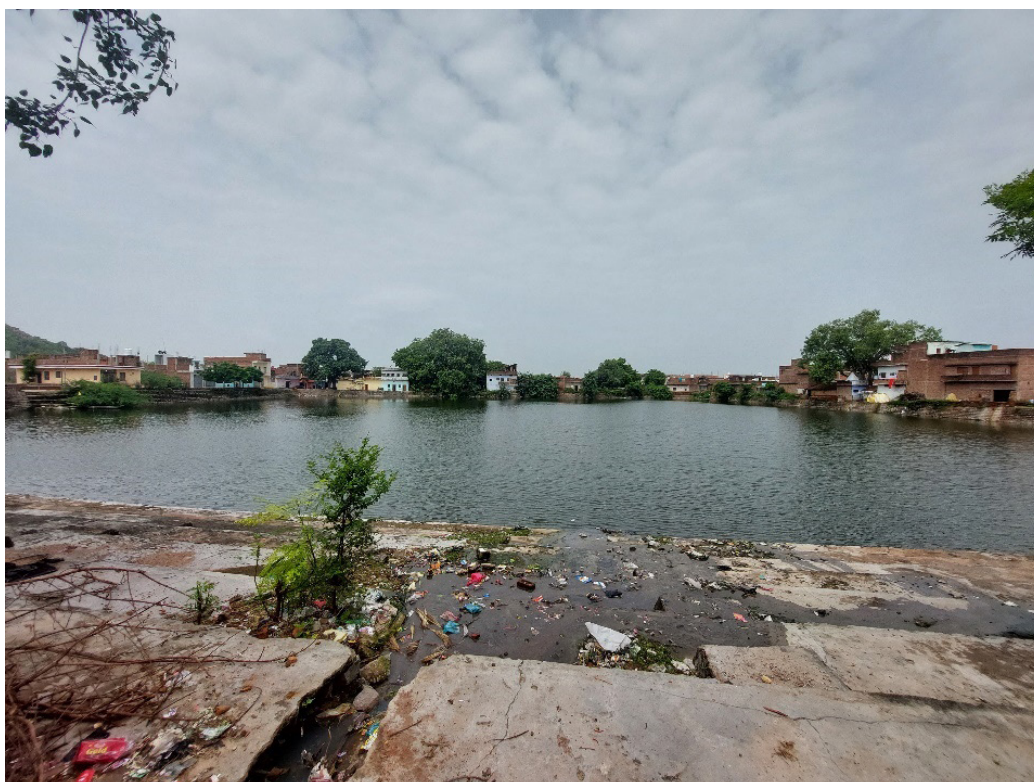
The unabated flow of wastewater from households into the Chabbi talab of Banda city degrades the water quality of the talab. The water stinks throughout the year.

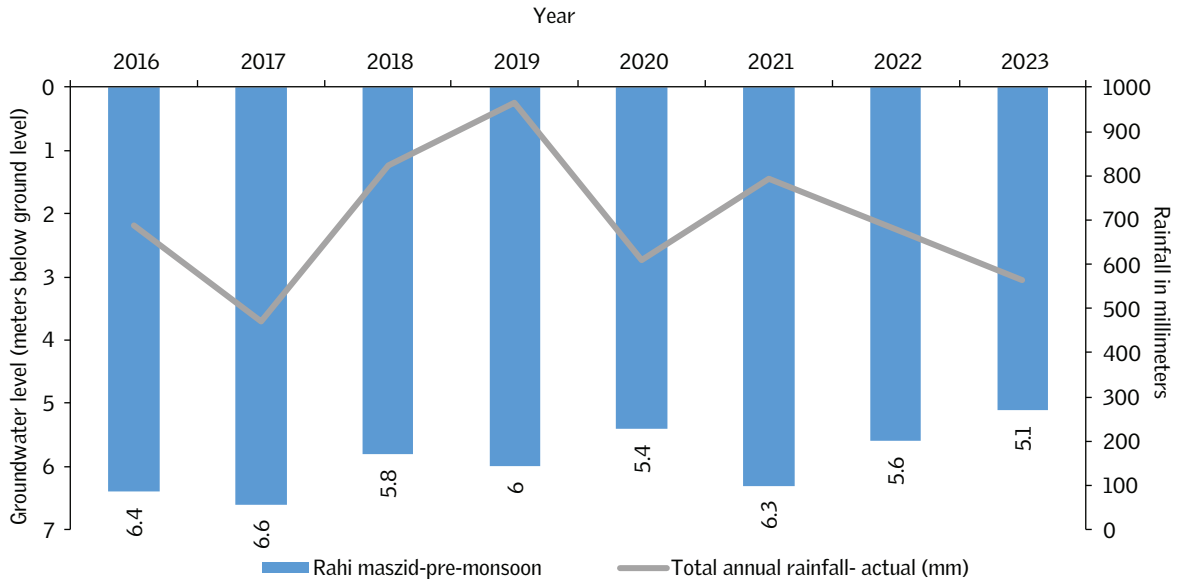
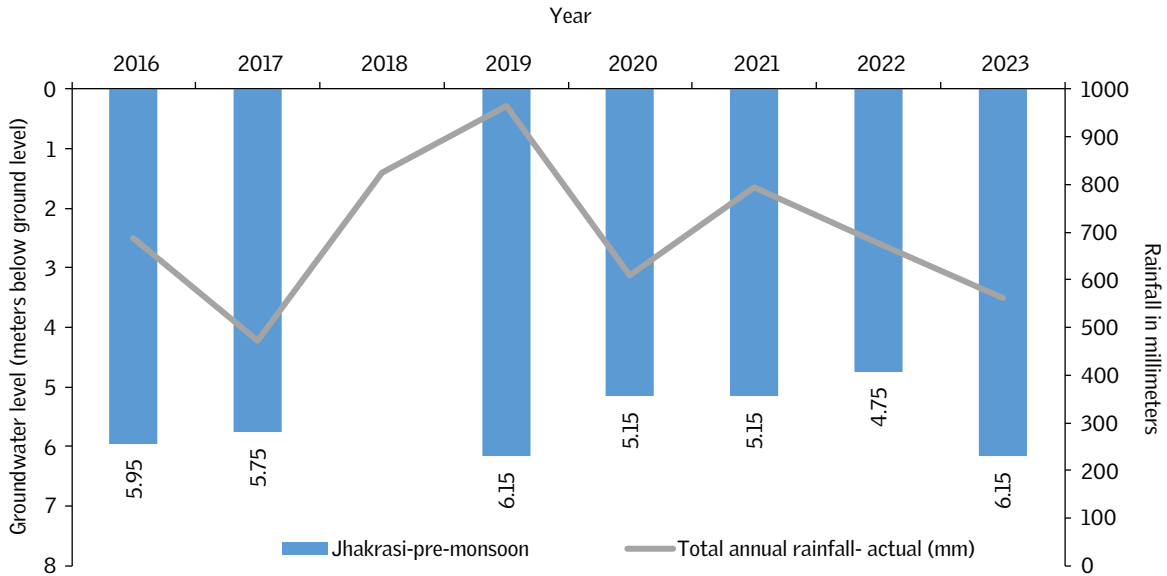
Figure 32: Rainfall data and groundwater levels in Rae Bareli

Groundwater data from well versus total rainfall-Rahi Maszid-Rahi block

Groundwater data from wells versus total rainfall-Jhakrasi-Rahi block

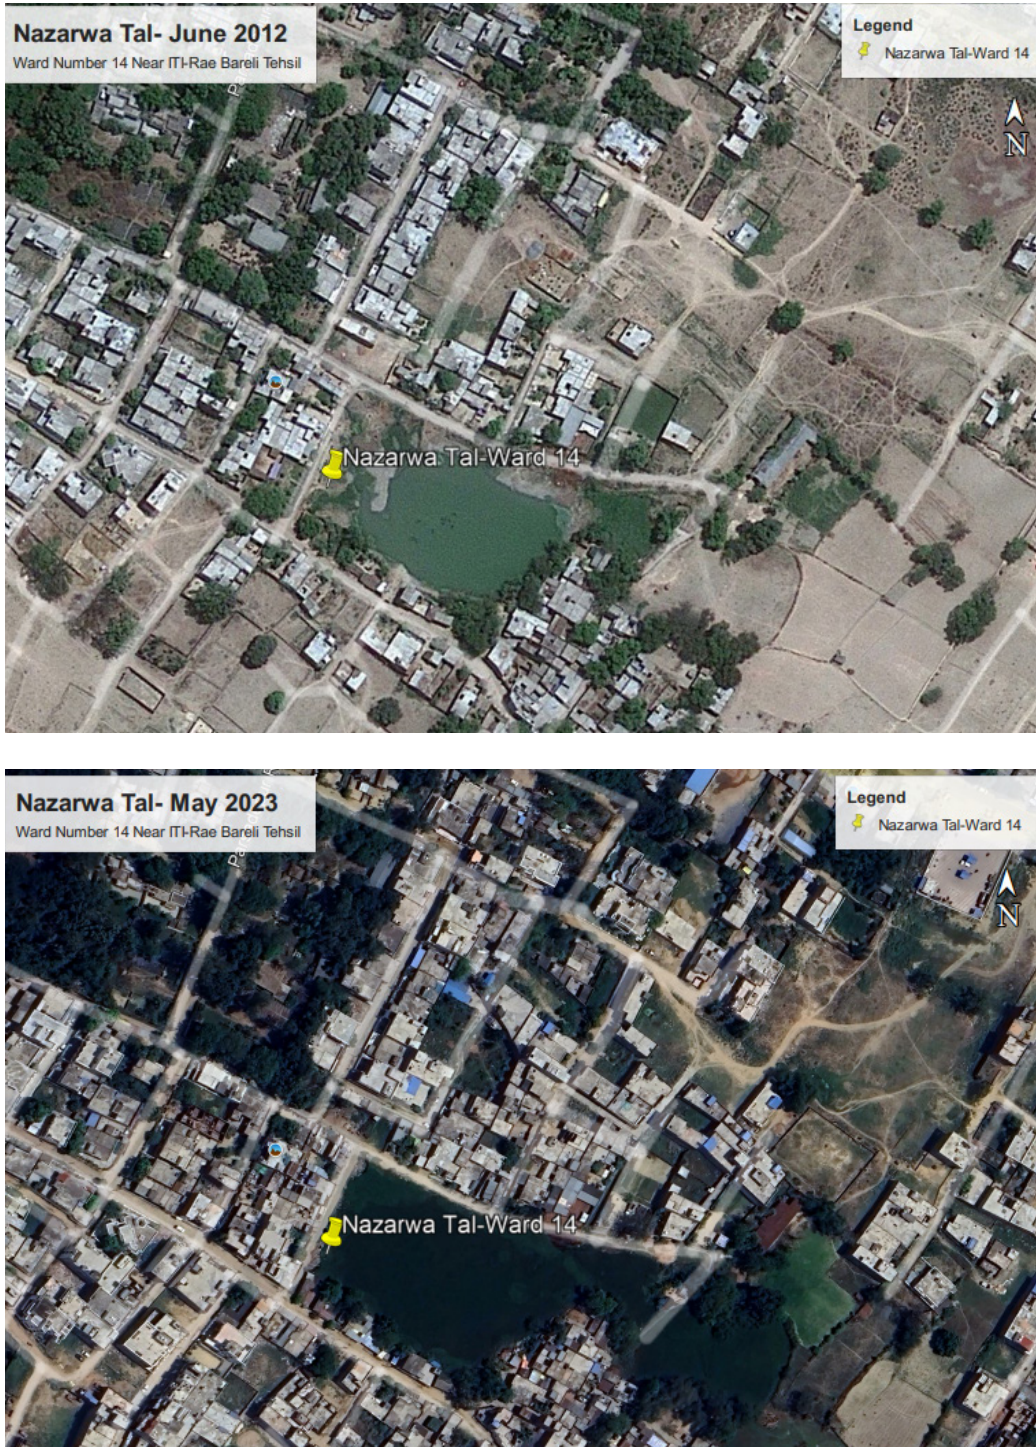
Pollution level in the waterbodies increased between 2012 and 2023. The increased number of settlements between these years near the waterbody caused increase in sewage inflow into the tal
