# **Plan for restoration of cascading tank systems in Anuradhapura district, Sri Lanka**

Sushmita Sengupta, Nitya Jacob and Hina Khan, December 2013

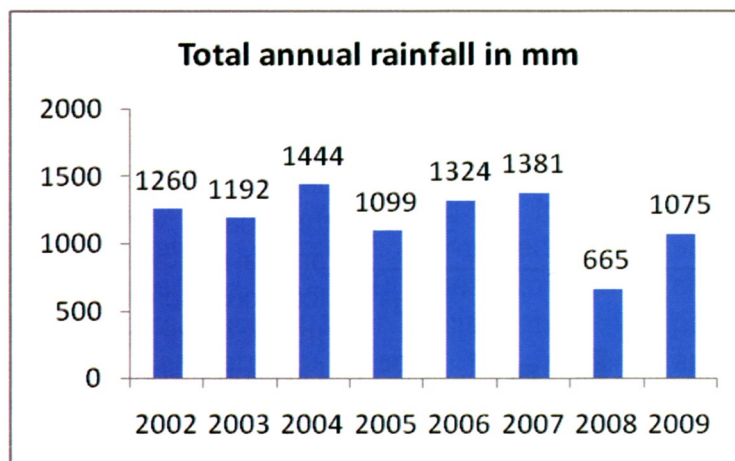
Fig 6: Annual rainfall in Anuradhapura district. Source: Anon 2010, Cascade Irrigation Systems for Rural Sustainability, Experience of Plan Sri Lanka's Cascade Systems Development Project in the North Central Province of Sri Lanka 2004-2010 . Plan India. 183 p.

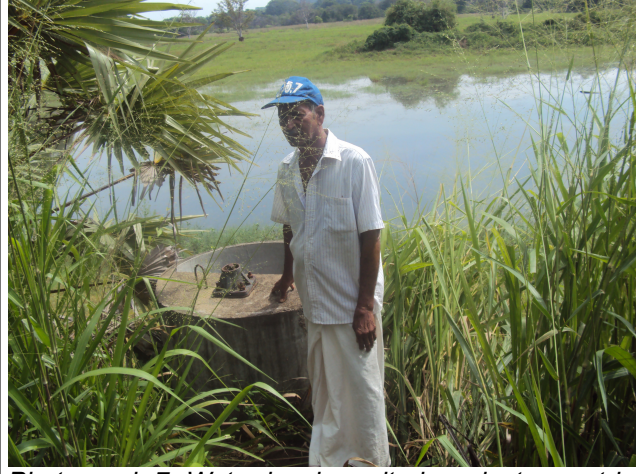
Photograph 7: Water level monitoring instrument in Wagayankulama wewa in Anuradhapura district. Source: Sushmita Sengupta, Water Team, CSE

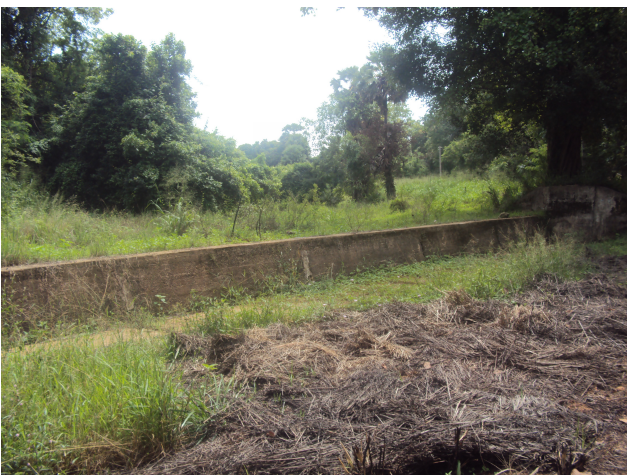
Photograph 8: Sluice for tackling runoff from Periakulam wewa to Pudukulam wewa in Anuradhapura district. Source: Sushmita Sengupta, Water Team, CSE

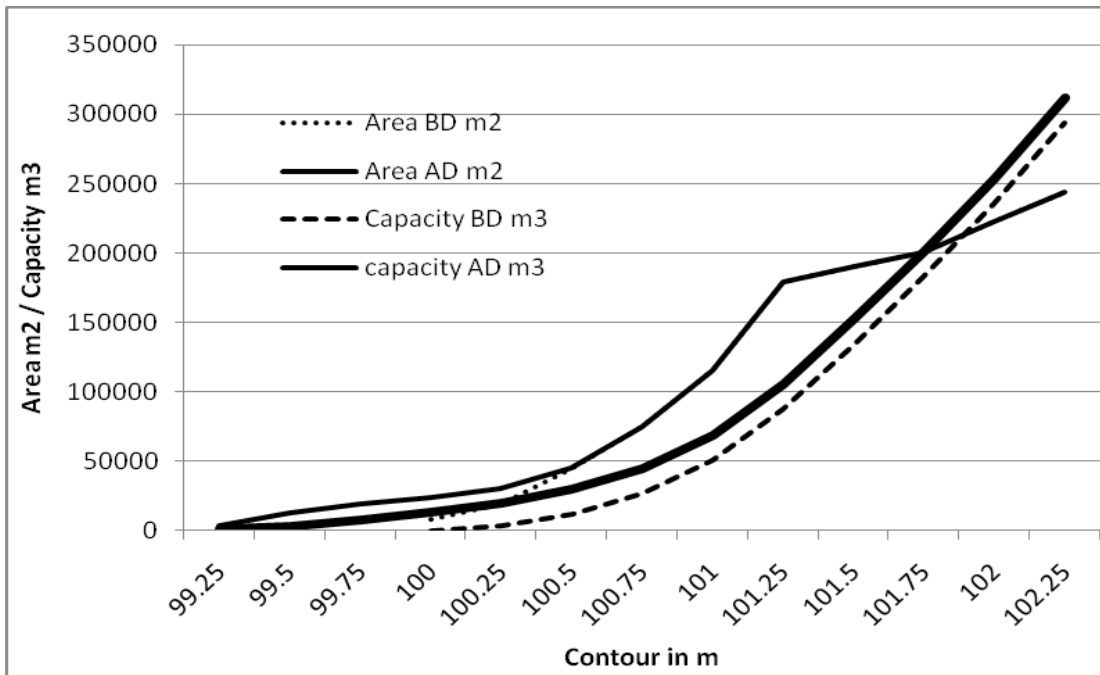
Fig 8. Area /capacity curve before and after deepening in Wagayankulama tank. Source: Department of Agriculture

There was an alteration of the geometry of the tank bed in Wagayankulama wewa with the partial desilting work of the tank. During partial desilting, the silt that was removed from the shallower part of the tank was again added to the tank (in the deeper regions) to form mounds. Thus the tank geometry was altered to form a high capacity : area ratio as the surface area was reduced to half. Thus the moist tank soil (which was used to make the mound) was used to grow bamboo (*Bambusa spp.*), rattan (*Calamus spp.*), mat grass (*Cyperus pangorei*) etc. The development of the dead storage (water storage below the sluice level) created by removing the silt increased the water stored in this area. This extra water could be used for cultivation in the tank command area.

To reduce tank water losses, partial desiltation is the best process in this case. This can be done by changing the tank bed geometry through desiltation. It is clear that the said objective cannot be successfully achieved by a complete desiltation, as desiltation does not alter the area/height ratio of the tank storage effectively (Photograph 10 and Figure 7). Thus, the same capacity can be maintained by removing sediment in this area and spread and making soil mound over the rest of the tank bed. Such partial desilting effort would reduce the area/height ratio remarkably. In order to prevent sediment moving back to the desilted area there is a need to stabilize the soil mound with a vegetative cover. Therefore, the technique of partial desiltation increases the storage potential and reducing tank water losses with protecting the ecosystem. Department of Agriculture carried on such project in one of the tanks in a cascading system and got positive results (Tables 1 and 2 and Figure 10).
