# ASSESSMENT REPORT OF PASAKHA INDUSTRIAL ESTATE, PHUNTSHOLING, BHUTAN

FEBRUARY 2019

**Prepared by:**  
Centre for Science and Environment

**For:**  
The National Environment Commission  
Royal Government of Bhutan

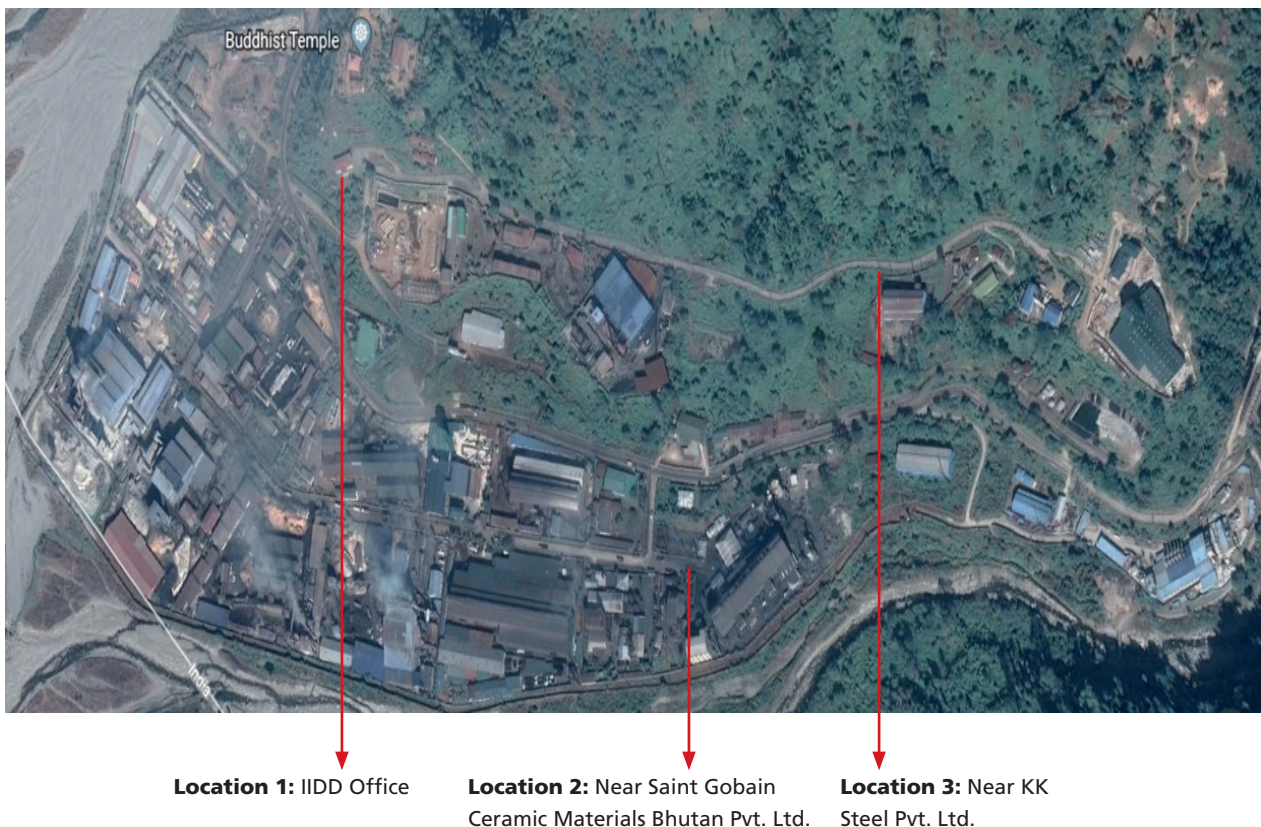
Figure 4: Monitoring locations where ambient air monitoring was done on the Pasakha map

The 24 hour monitoring was carried out at Industrial Infrastructure Development Division (IIDD) office, Saint Gobain Ceramic Material Bhutan Pvt. Ltd. and K. K. Steel Pvt. Ltd.

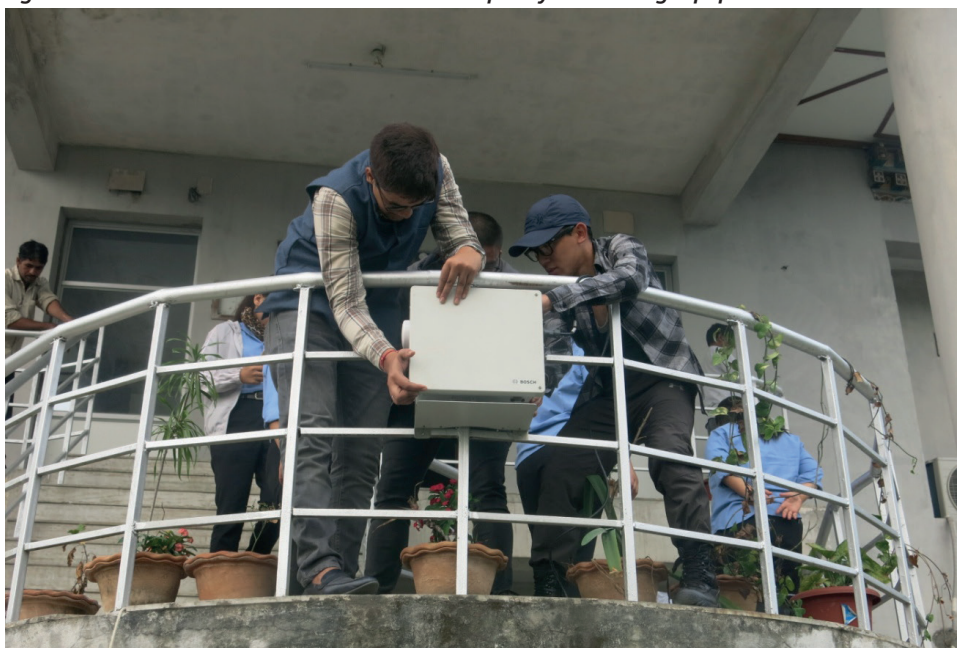
Here, the particulate concentration was found to be exceeding the permissible limits. Both PM10 and PM2.5 average values were very high, the average recorded value of PM10 was  $284.59 \mu\text{g}/\text{m}^3$  and PM2.5 was  $250.57 \mu\text{g}/\text{m}^3$ . The values were found to be high for most of the time; approximately 75 per cent of the time the value exceeded the permissible limit of  $200 \mu\text{g}/\text{m}^3$  prescribed by the Ambient Air Quality Standards of the Environmental Standards 2010 of Bhutan.

Other parameters CO and SO2 were within the limits. NO2 was within the limit as well, but was approaching the maximum prescribed limit. The average value

**Figure 5: Installation of continuous ambient air quality monitoring equipment near IIDD office**

recorded was 116.24  $\mu\text{g}/\text{m}^3$  whereas the maximum prescribed standard is 120  $\mu\text{g}/\text{m}^3$ .

The instantaneous monitoring was also done near IIDD office and the results substantiated the higher values for PM10, PM2.5 and TSP. The recorded average value for 1 hour instantaneous monitoring done near the IIDD office was 141  $\mu\text{g}/\text{m}^3$  for PM2.5; for PM10, the value was 292  $\mu\text{g}/\text{m}^3$  and the TSP was recorded to be 359  $\mu\text{g}/\text{m}^3$ .

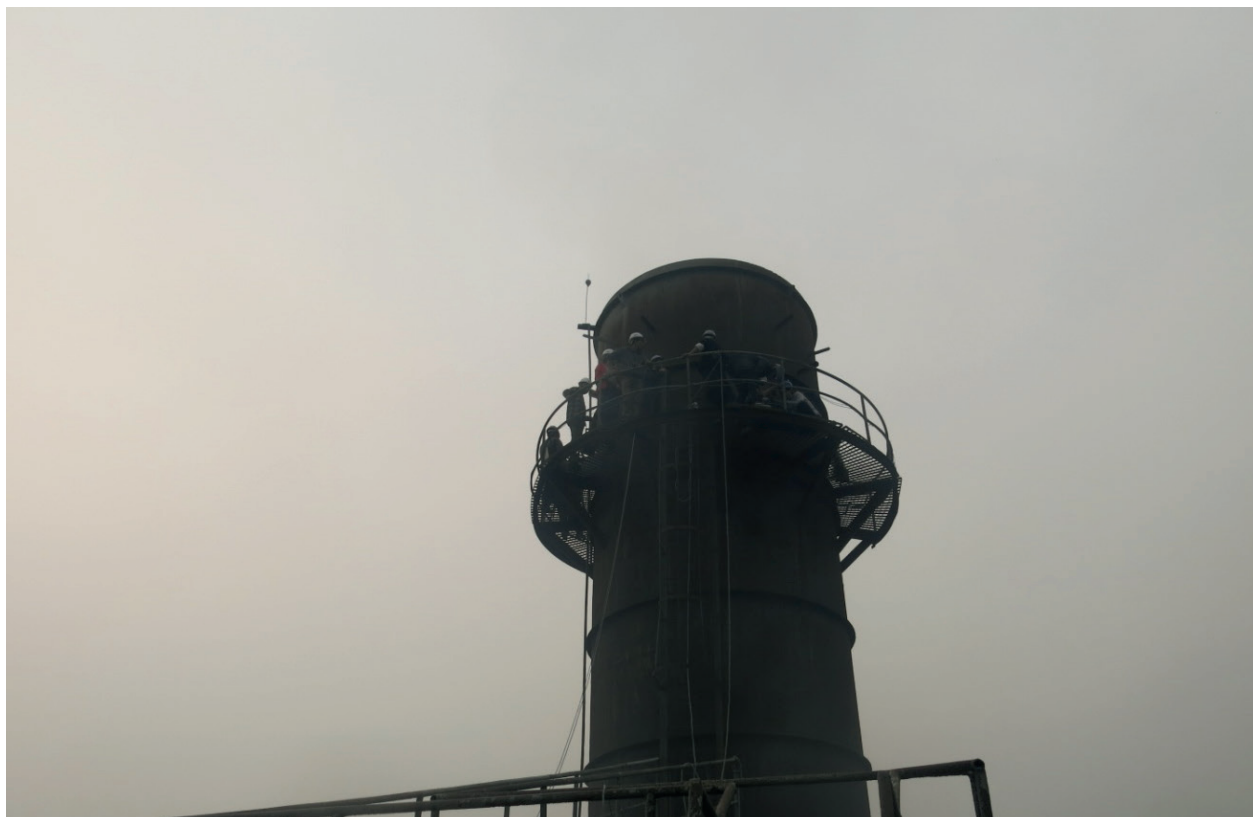
The monitoring result during tapping is presented in Table 6 below, and it is important to note here that in Emission Standards 2010 of Bhutan for industrial emission maximum permissible limits, no standard is prescribed for NO<sub>x</sub> and for SO<sub>2</sub> emission, the emission standard is only prescription for SPM. However, for other places like arc furnace, induction furnace, stacks, etc. the maximum prescribed limit is 100 mg/Nm<sup>3</sup> for both SO<sub>2</sub> and NO<sub>x</sub>.

**Figure 6: Monitoring of point source emission at a stack**

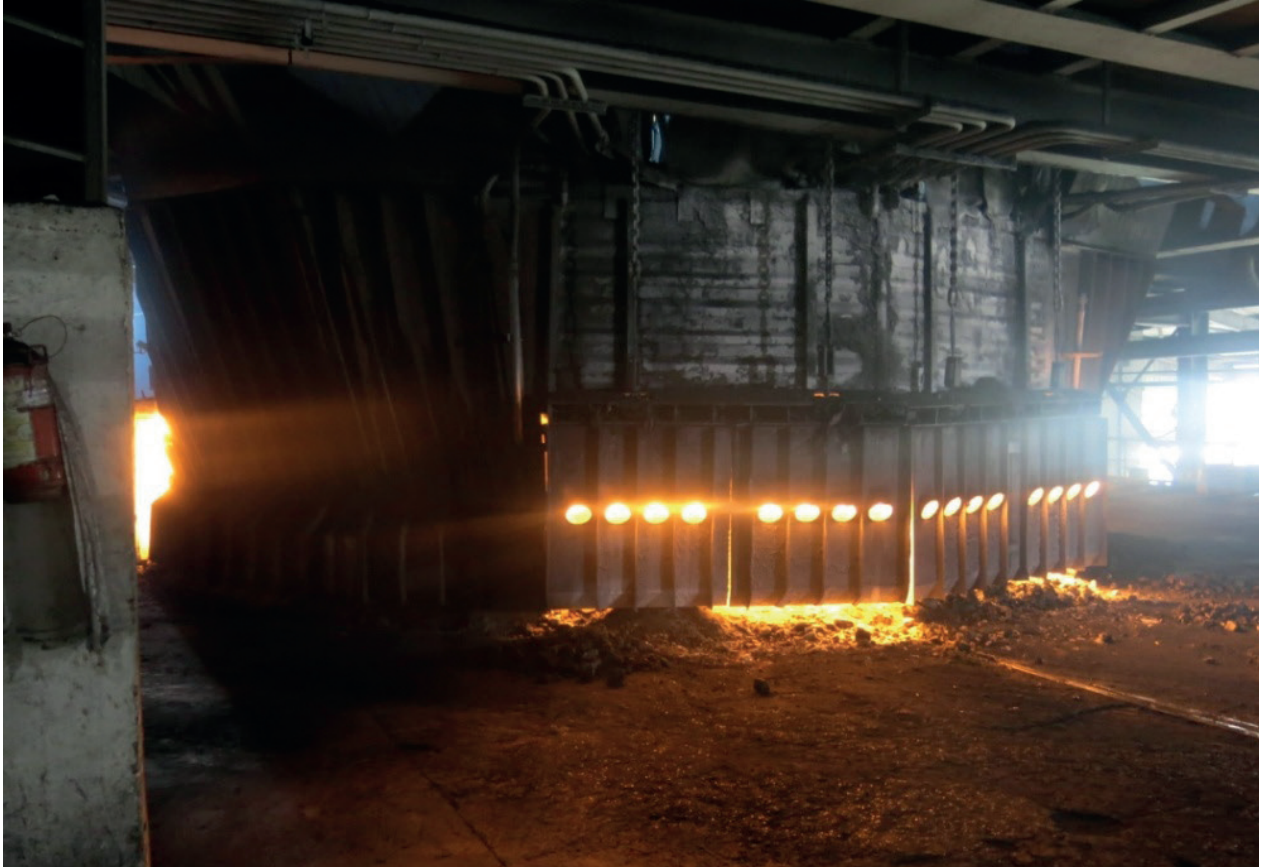
Some industries have proper door sealing system to close the furnace openings by hydraulically operated doors, thereby outside air does not enter the furnace and the extraction of emissions from furnaces is more effective (see Figure 16–17).

*Figure 16: Hydraulically operated furnace doors at a submerged arc furnace—Reduces fugitive emission*

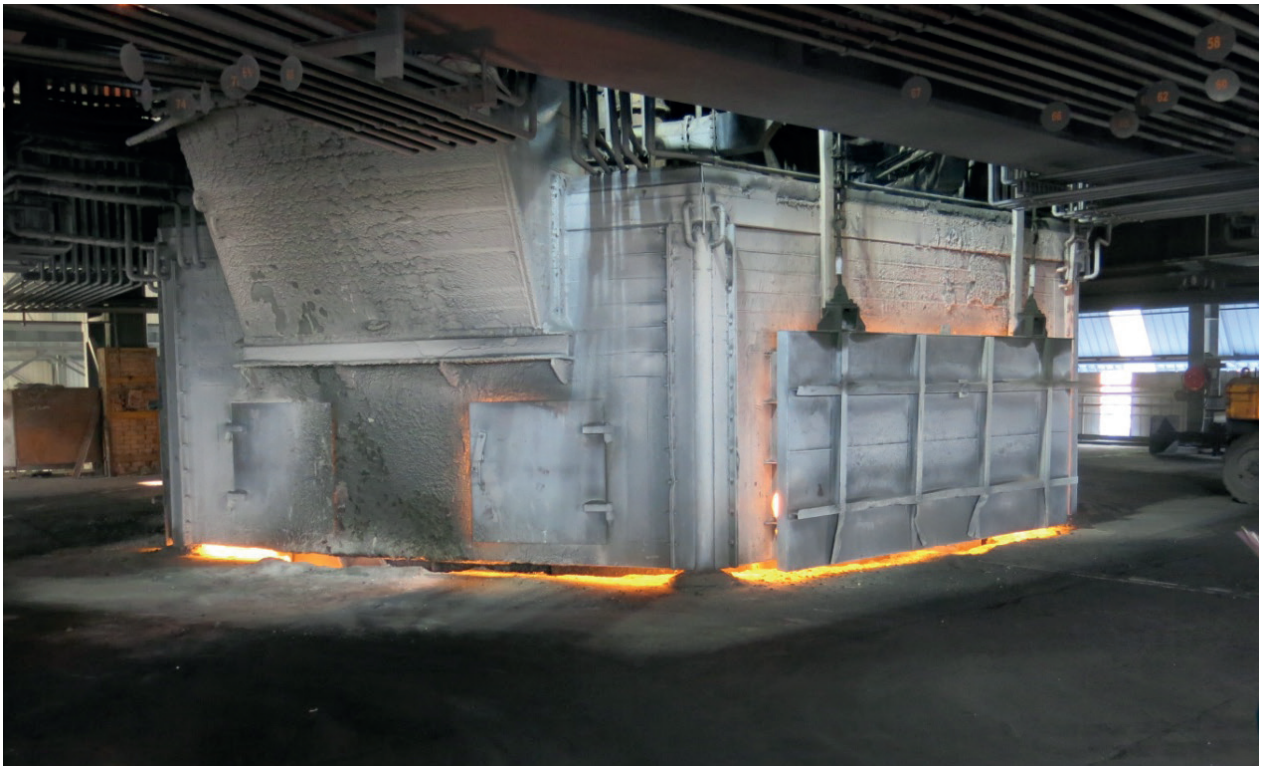
*Figure 17: Hydraulically operated furnace doors to control fugitive emission—Reduces fugitive emission*

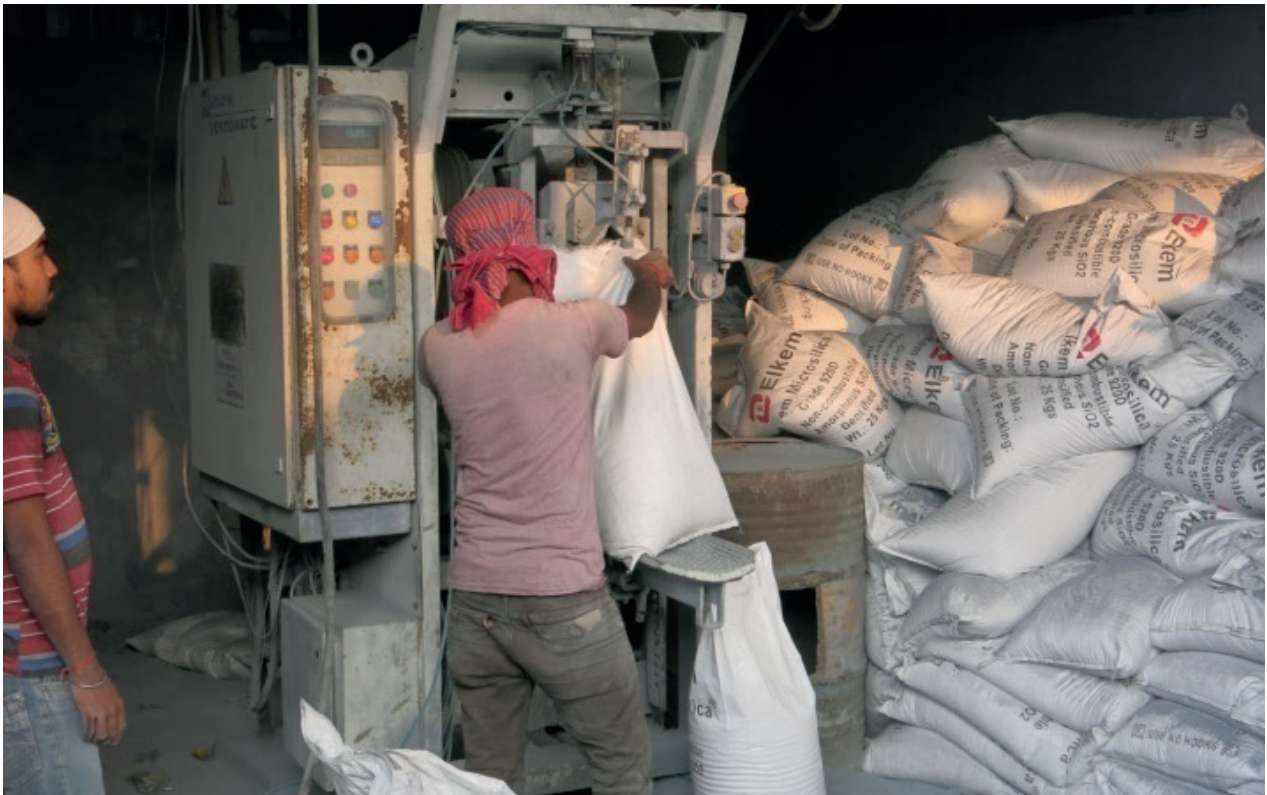
Figure 37: Mechanical dust collection system in one of the industries
